**Location:** Electrical – Wiring Harness

**Topic:** Warning light / message on IC with random symptoms. The DTC will be different according to the area where the body harness is damaged (engine bay area)

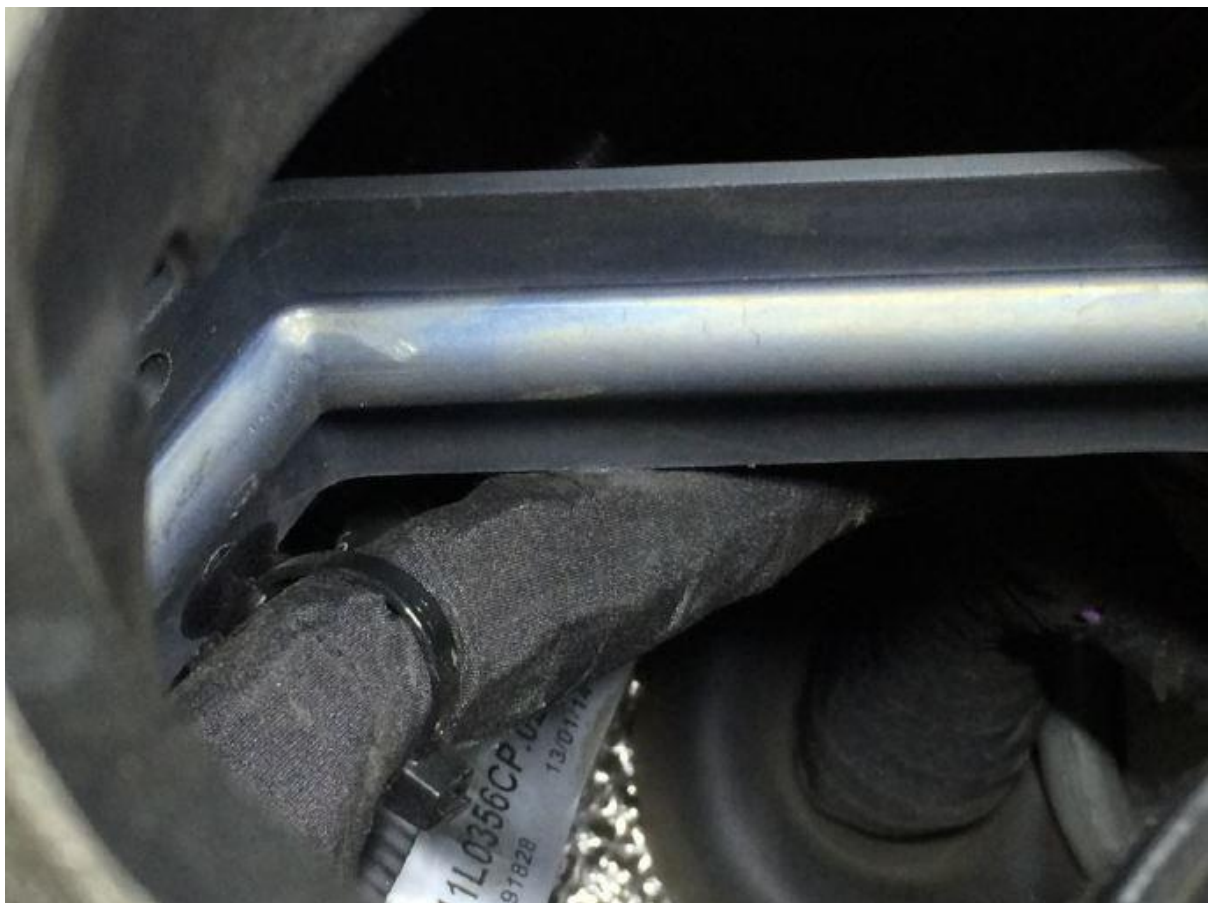
Various DTCs primarily logged in the PCCU. The faults can be related to the suspension circuit, power supply or ground to PCCU module etc.

1. Remove both rear wheel arch liners as per SIS instructions
2. Remove the air intake to airbox duct and airbox assembly
3. Carefully inspect the body harness if it is chafing against the support bracket as shown in the image within the Attachments section
4. Repeat the same on the opposite side
5. If the body harness is found to be damaged, reveal the damage by removing the sleeve of the harness and identify the wires that have been exposed and shorting to the bracket
6. Proceed and repair the wire(s) as per SIS instructions
7. Add a rubber protection sleeve onto the bracket (both sides) where the harness is sitting on, to avoid repeat failure
8. Once the repair is completed, clear all the DTCs and test the vehicle
