Vehicles affected: P11: 12C, 12C Spider, 650S, 650S Spider, 625C, 675LT, 675LT Spider, P12: P1, P13: 540C, 570S, 570S Spider, 570GT, P14: 720S, 720S Spider, P15: Senna

Location: Powertrain Engine - Cooling System

Concern: Coolant leak from the engine coolant pump

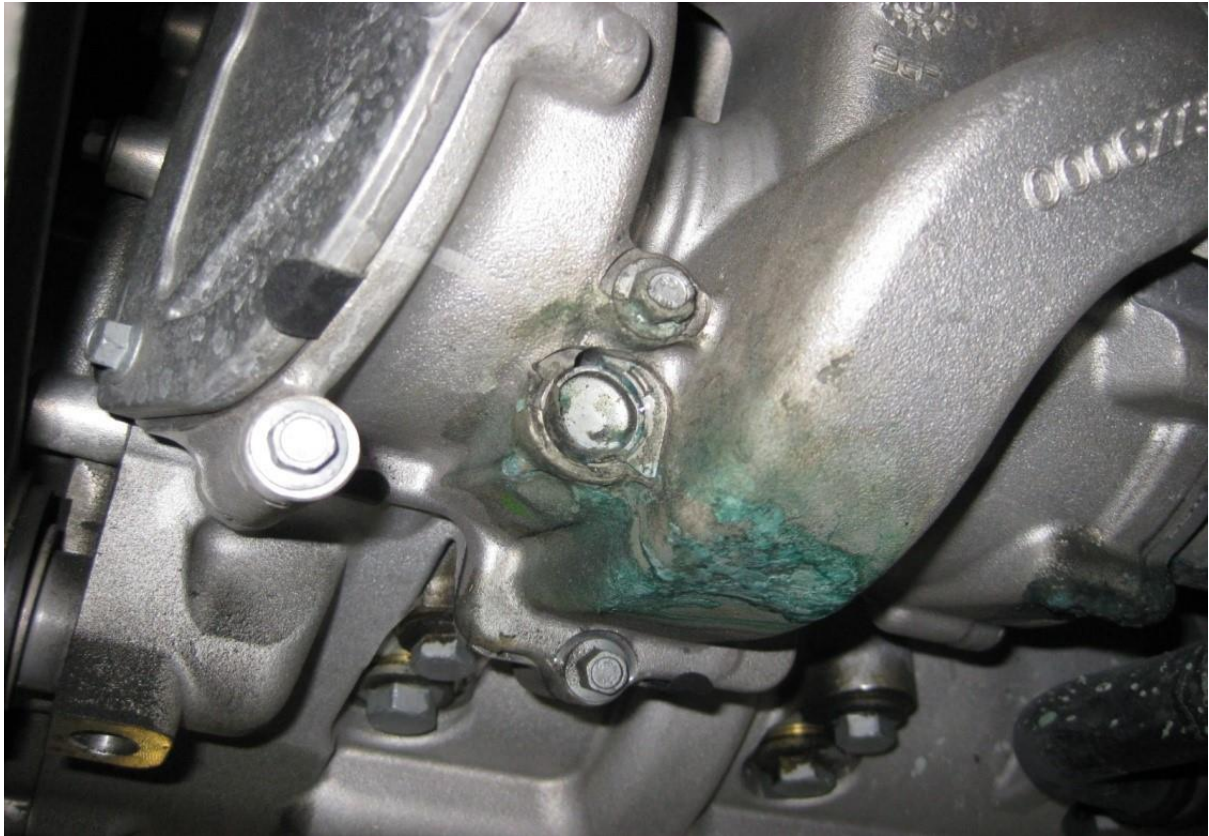
1. The side of the coolant pump where there is a blanking plug which covers the front evaporation chamber of the pump (early pump models only)

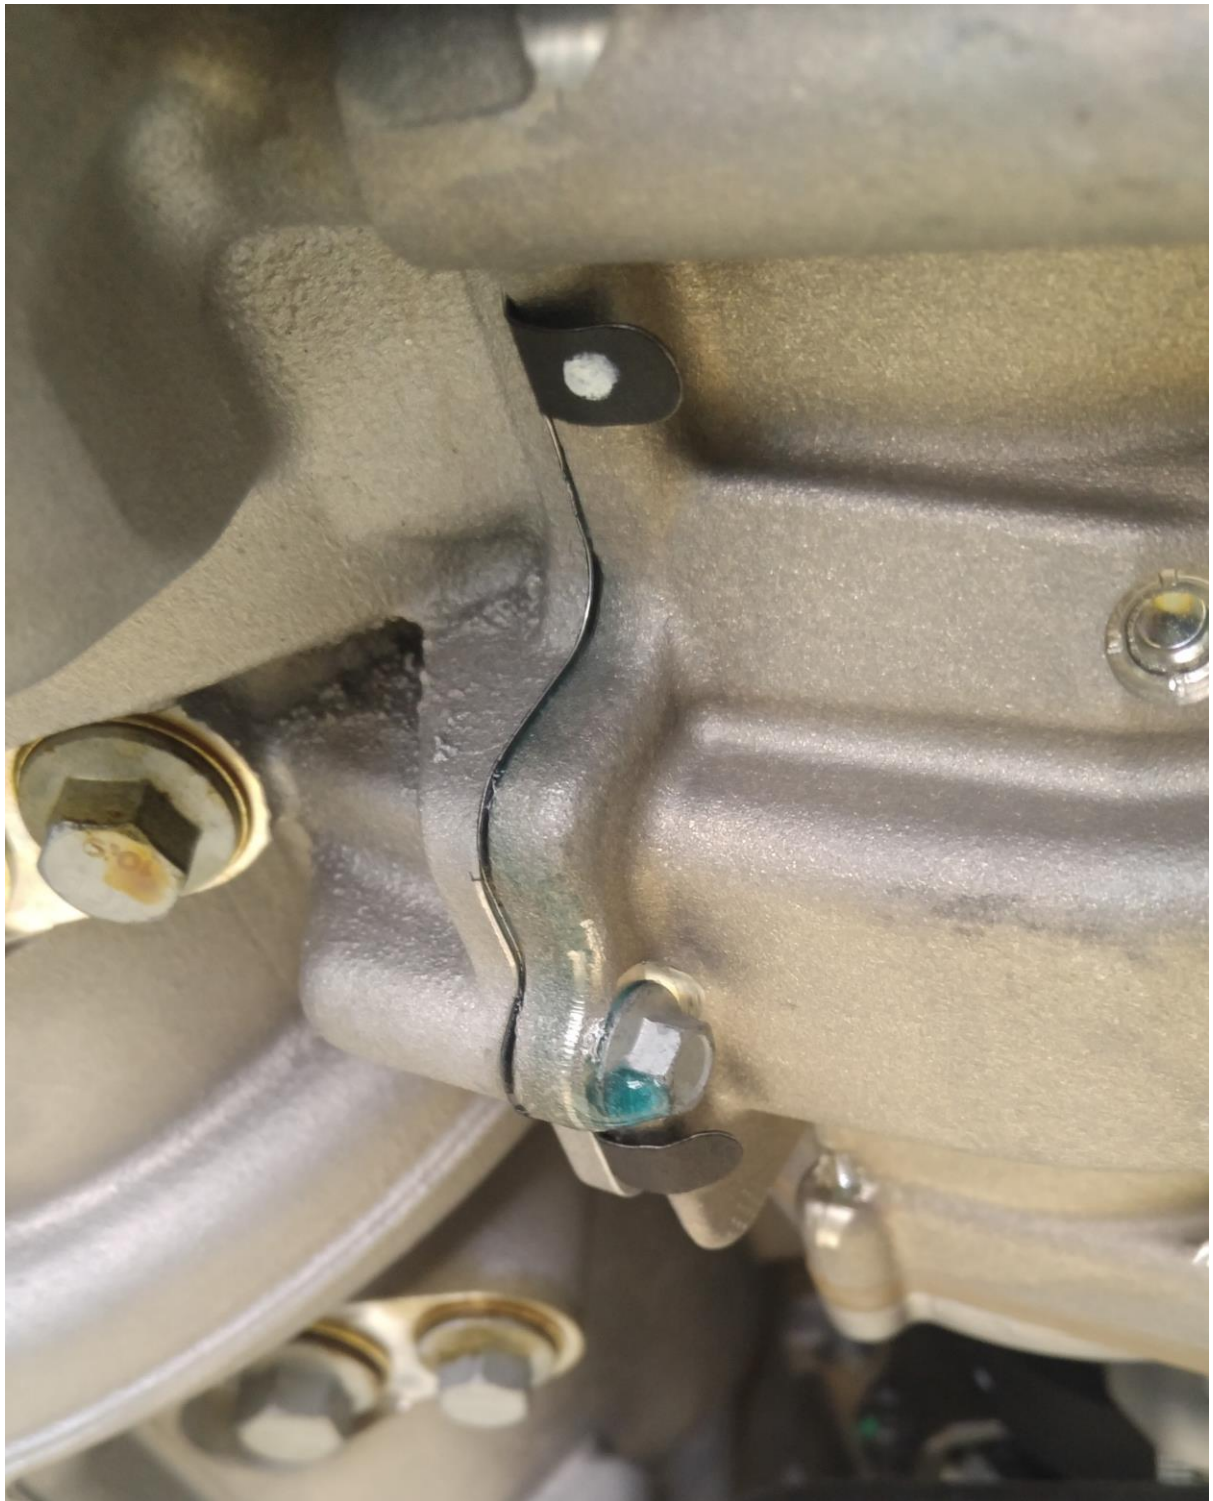
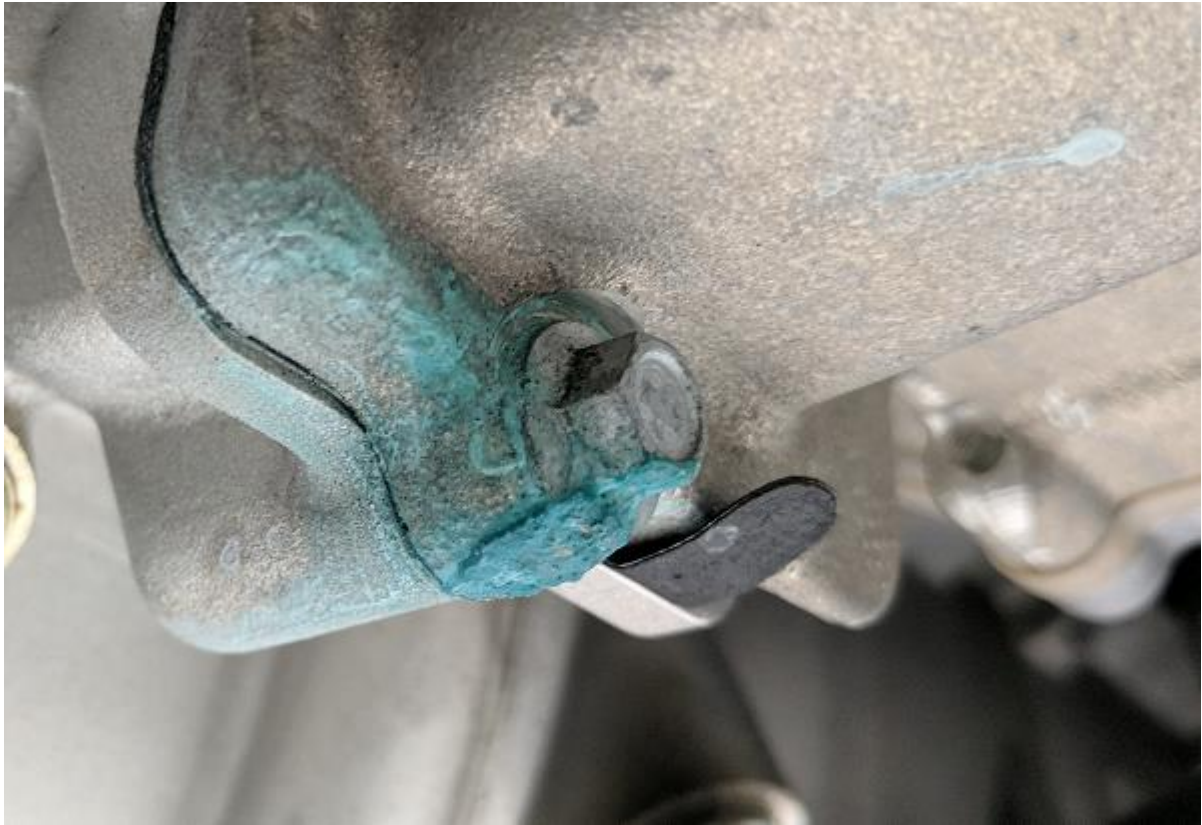
2. The front evaporation chamber exit, where the coolant pump casing seals to the engine (later pump models only). Staining can collect near bolt.

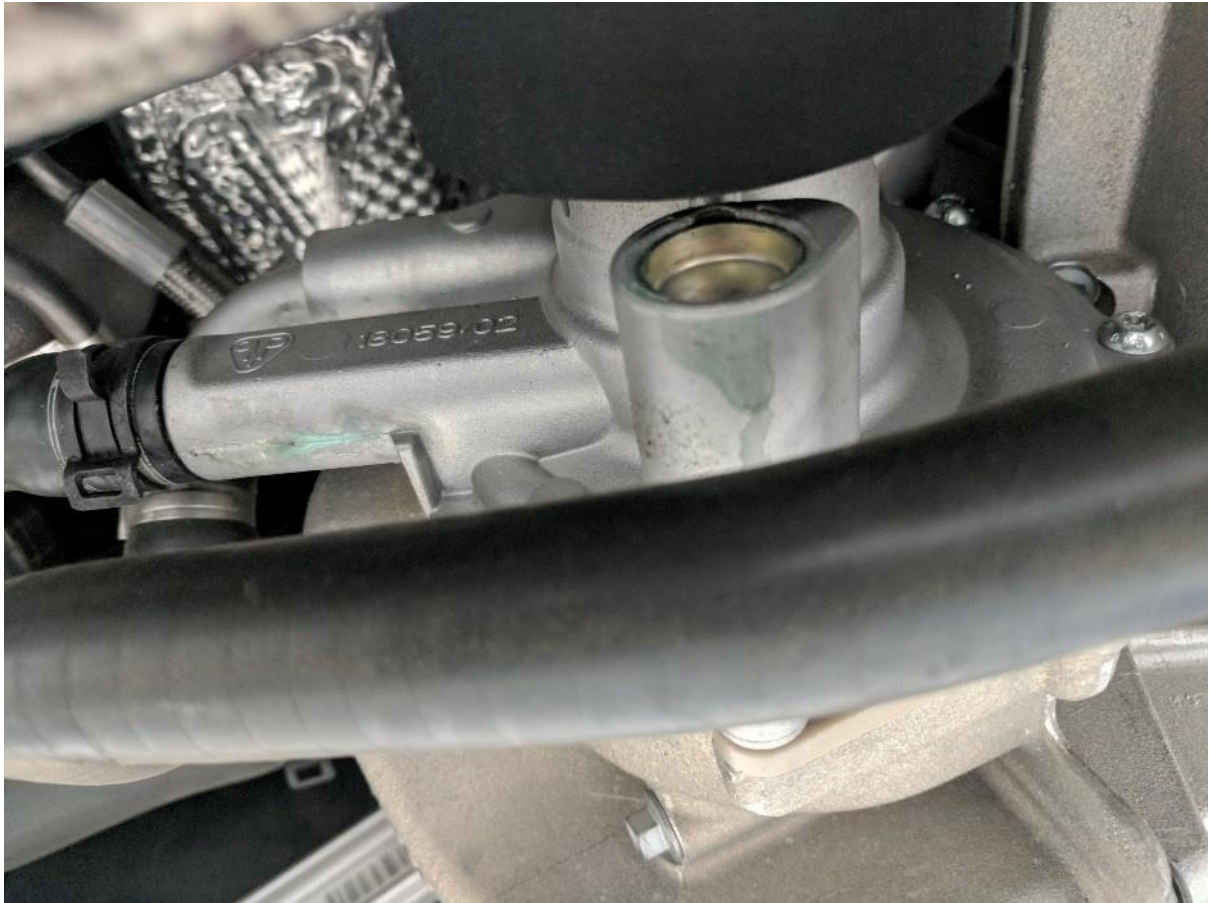
3. The rear of the coolant pump where there is a blanking plug which covers the rear evaporation chamber of the pump.
