Location: Powertrain Transmission – Rear Axle

Topic: Clutch oil leak from the SAV block

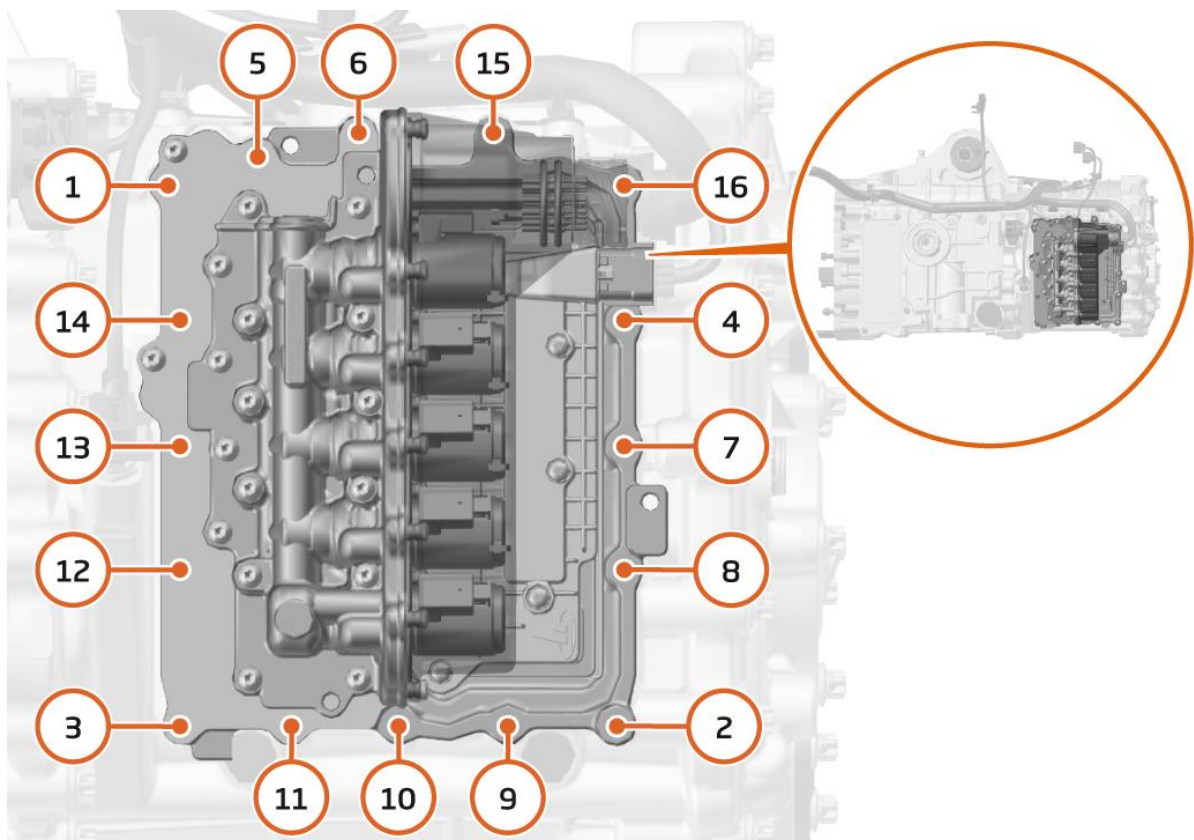
Care Point: Ensure the sequence (1 - 10) demonstrated in the image below is followed when removing / installing the SAV bolts.

4. Remove the SAV block bolts **one at a time** and apply Loctite 242 around the thread.
5. Re-install each bolt before the next one is removed and apply torque 10 Nm.
6. Once the above steps are completed, check the clutch and transmission oil level and top-up if required.
7. Perform a test drive until the engine and transmission are in operating temperature.
8. Return to the workshop and check for further leaks.
9. If no leak is present, no further action is required.
10. If the leak is still present from SAV block, capture some new photos of the leak.
11. Submit a Technical Request with all the above information and attach a copy of the Transmission Diagnostic Checklist form.
