Location: Powertrain Transmission – Rear Axle

Topic: Clutch oil leak between the clutch and gearbox casings

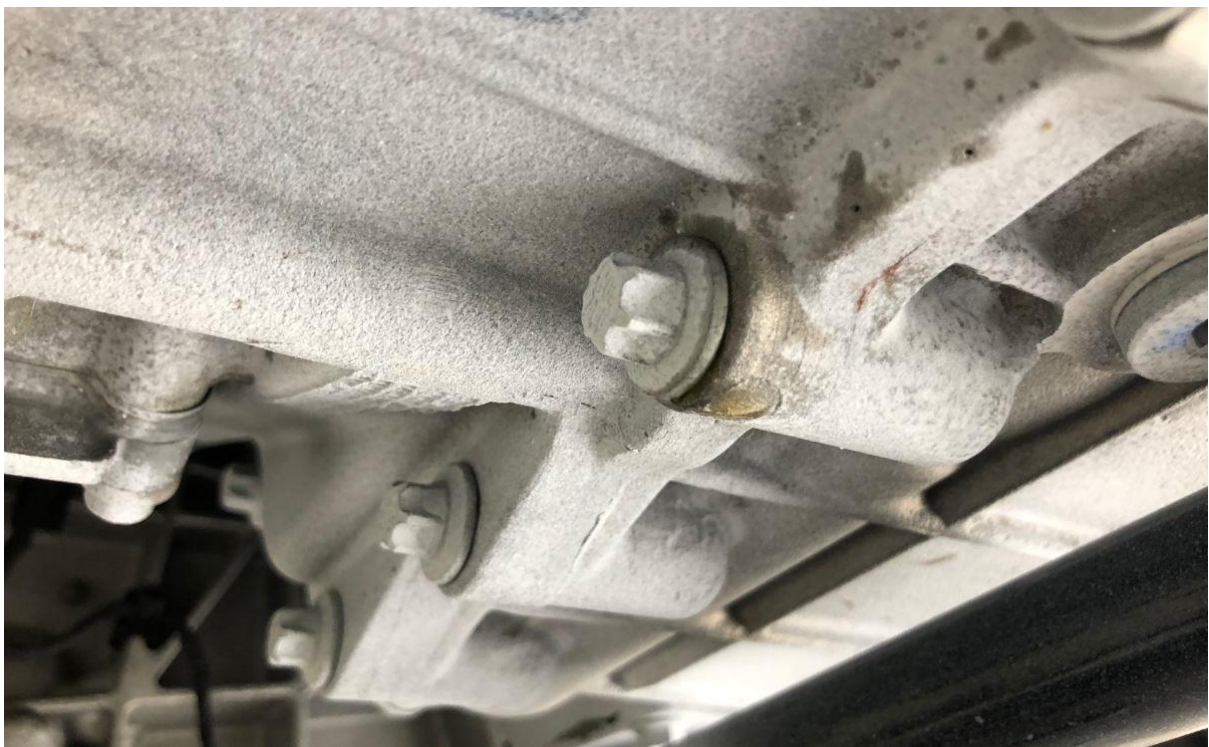
If a leak between the clutch and gearbox housing has been identified (as shown in the image below), follow the steps included in this document before considering replacing the transmission.

Note: A leak between the clutch and transmission casings may be due to porosity in the threaded holes.

1. Capture images of the area with the leak
2. Clean up and dry the transmission
3. Apply leak detector spray in the area that has previously leaked
4. Bring vehicle to operating temperature (test drive if necessary)
5. Inspect the transmission to confirm the source of the leak (if still present)
6. Capture new images of the leak
7. If the leak is confirmed that is between the two casings, proceed to the next step. If no further leaks have appeared no further action is required.

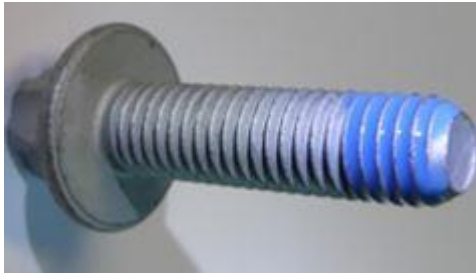
8. Remove the bolts shown in the image below one at a time.

9. Clean the residual oil from the casing and the bolt
10. Apply Loctite 242 on the screw as shown below
11. Re-install the bolt and torque to 32Nm
12. Repeat the above procedure for all five bolts
13. Bring vehicle to operating temperature (test drive if necessary)
14. Inspect the transmission to confirm if the leak is still present
15. If the leak remains, please raise a Technical Request and refer to this KA.
