Description

Electrical – Wiring Harness –

P13: 570S, 570GT, 570S Spider, 540C, 600LT, 600LT Spider.

Refer to this article if customer complained for engine warning light and/or engine running fault.

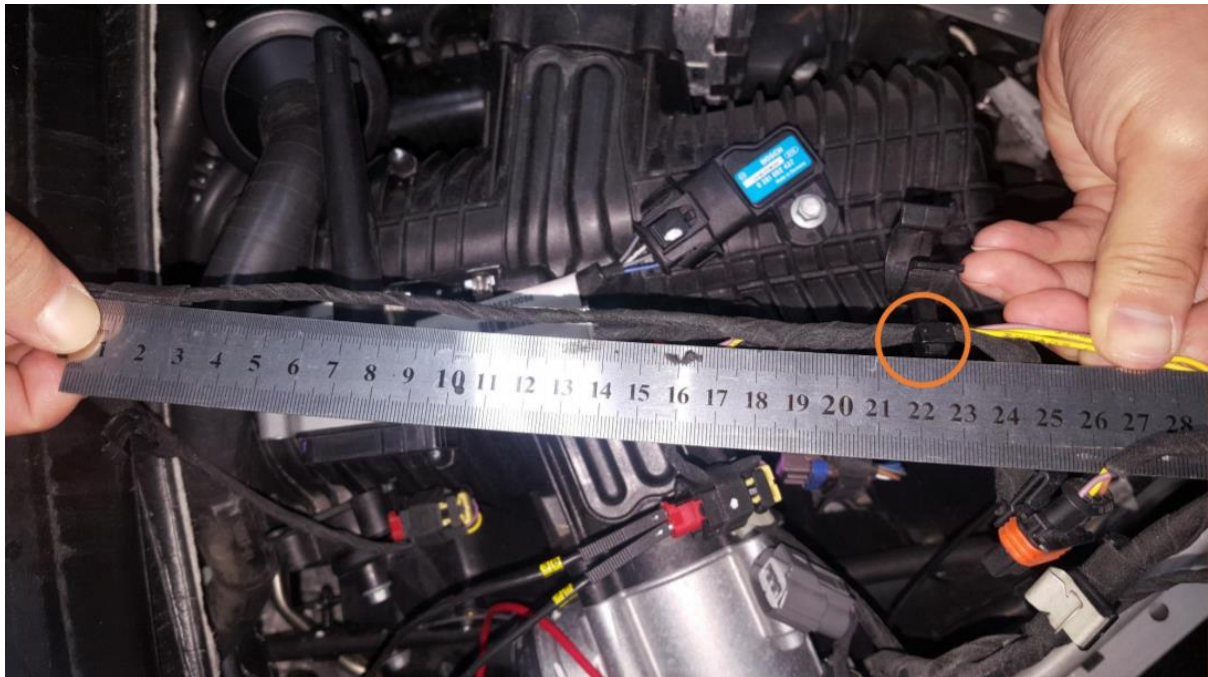
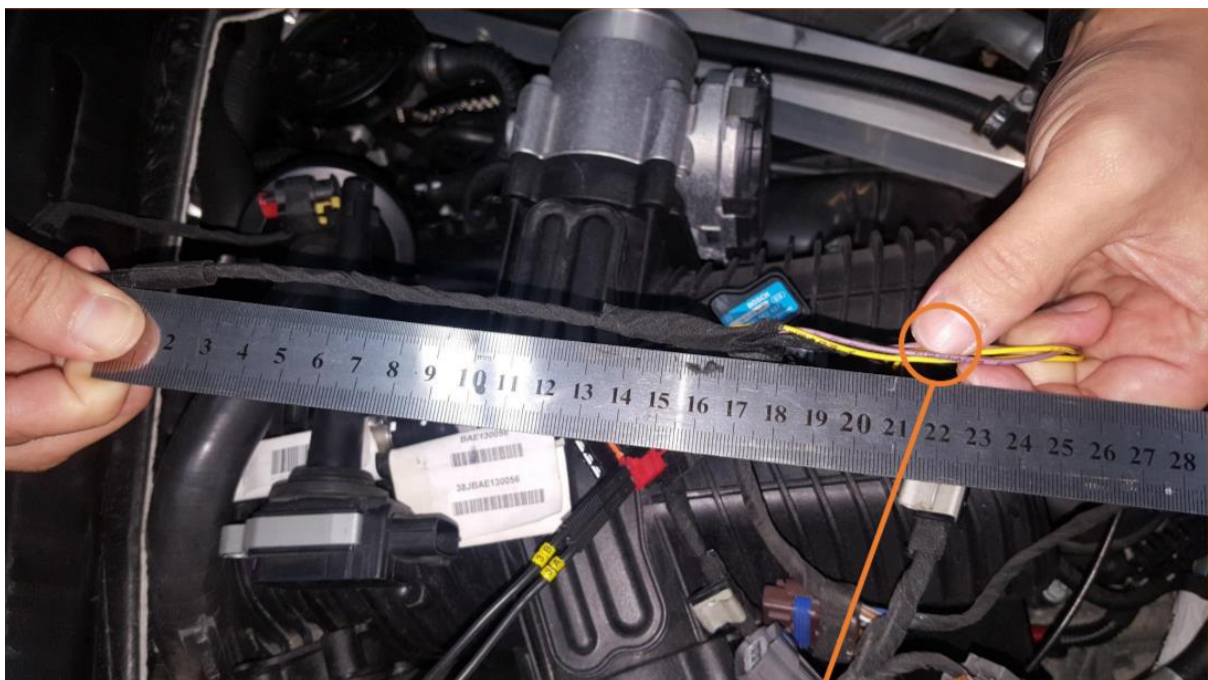
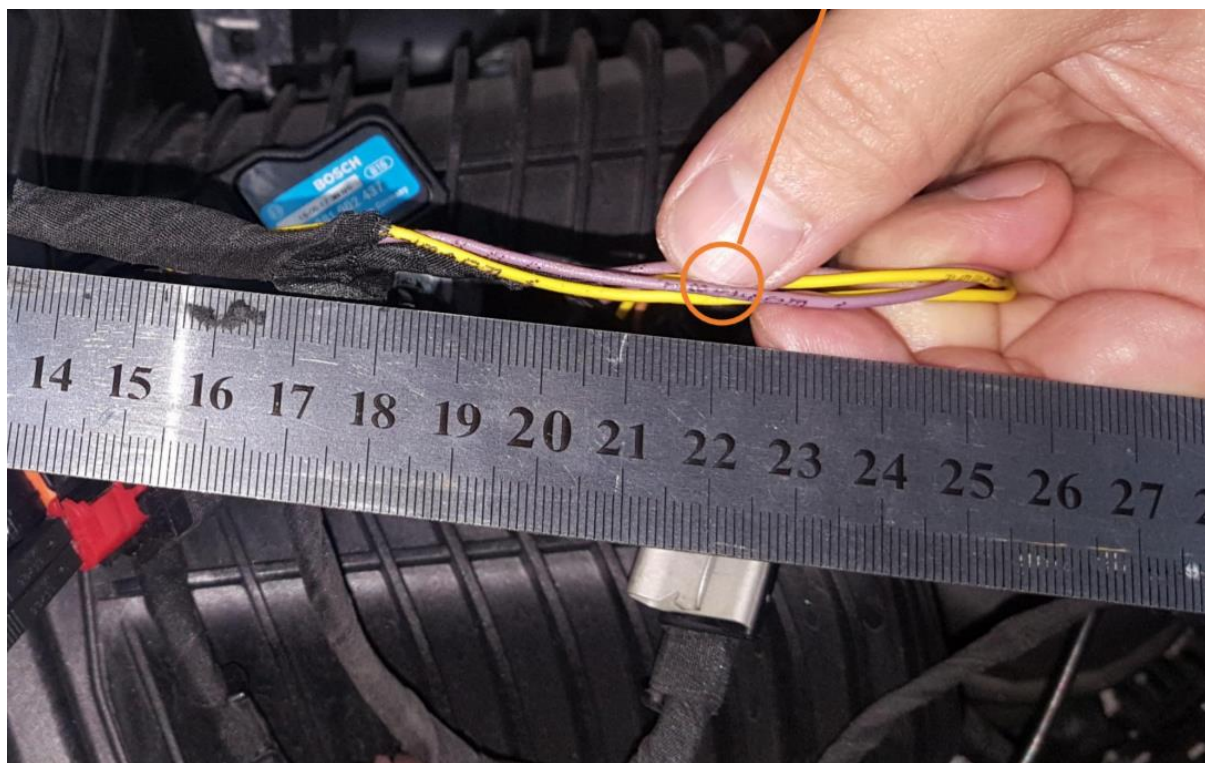
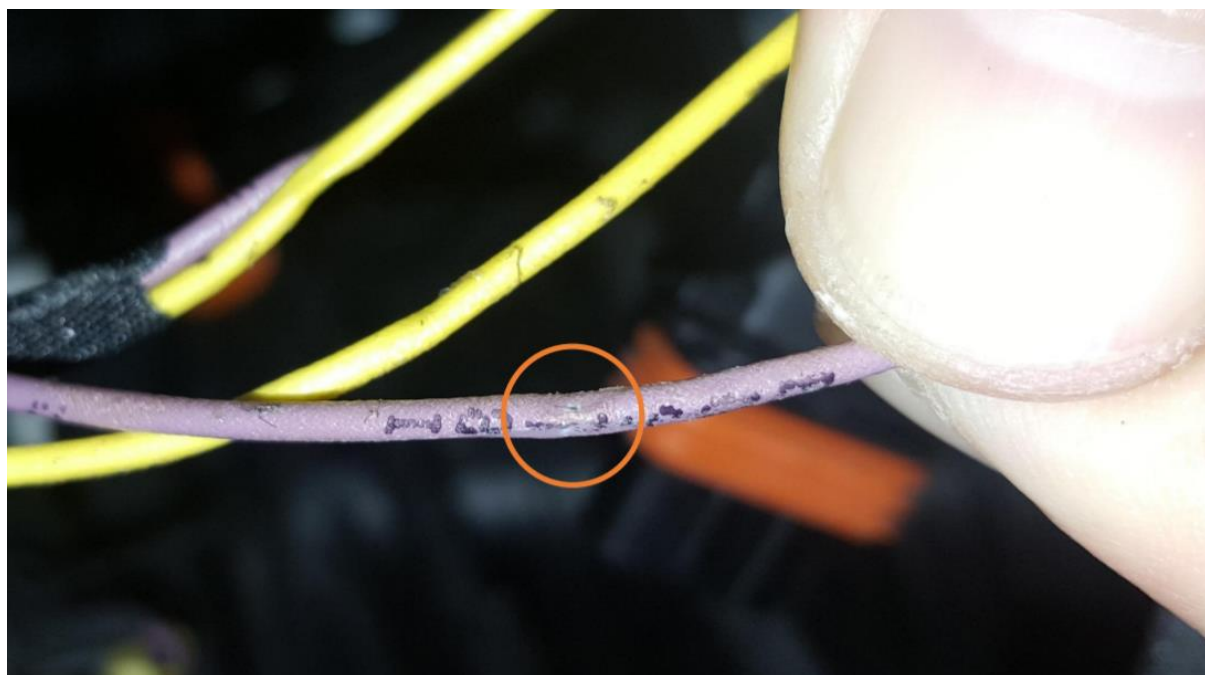
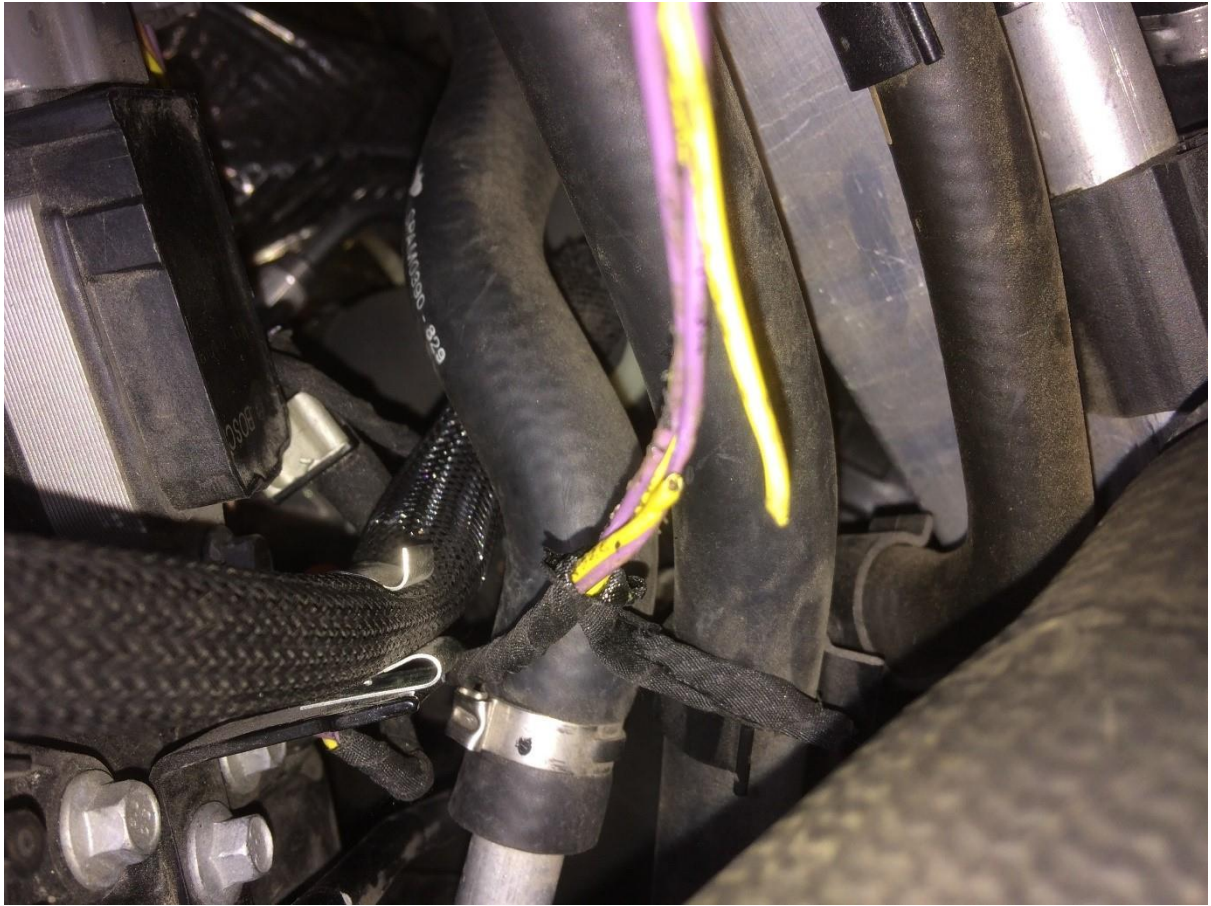
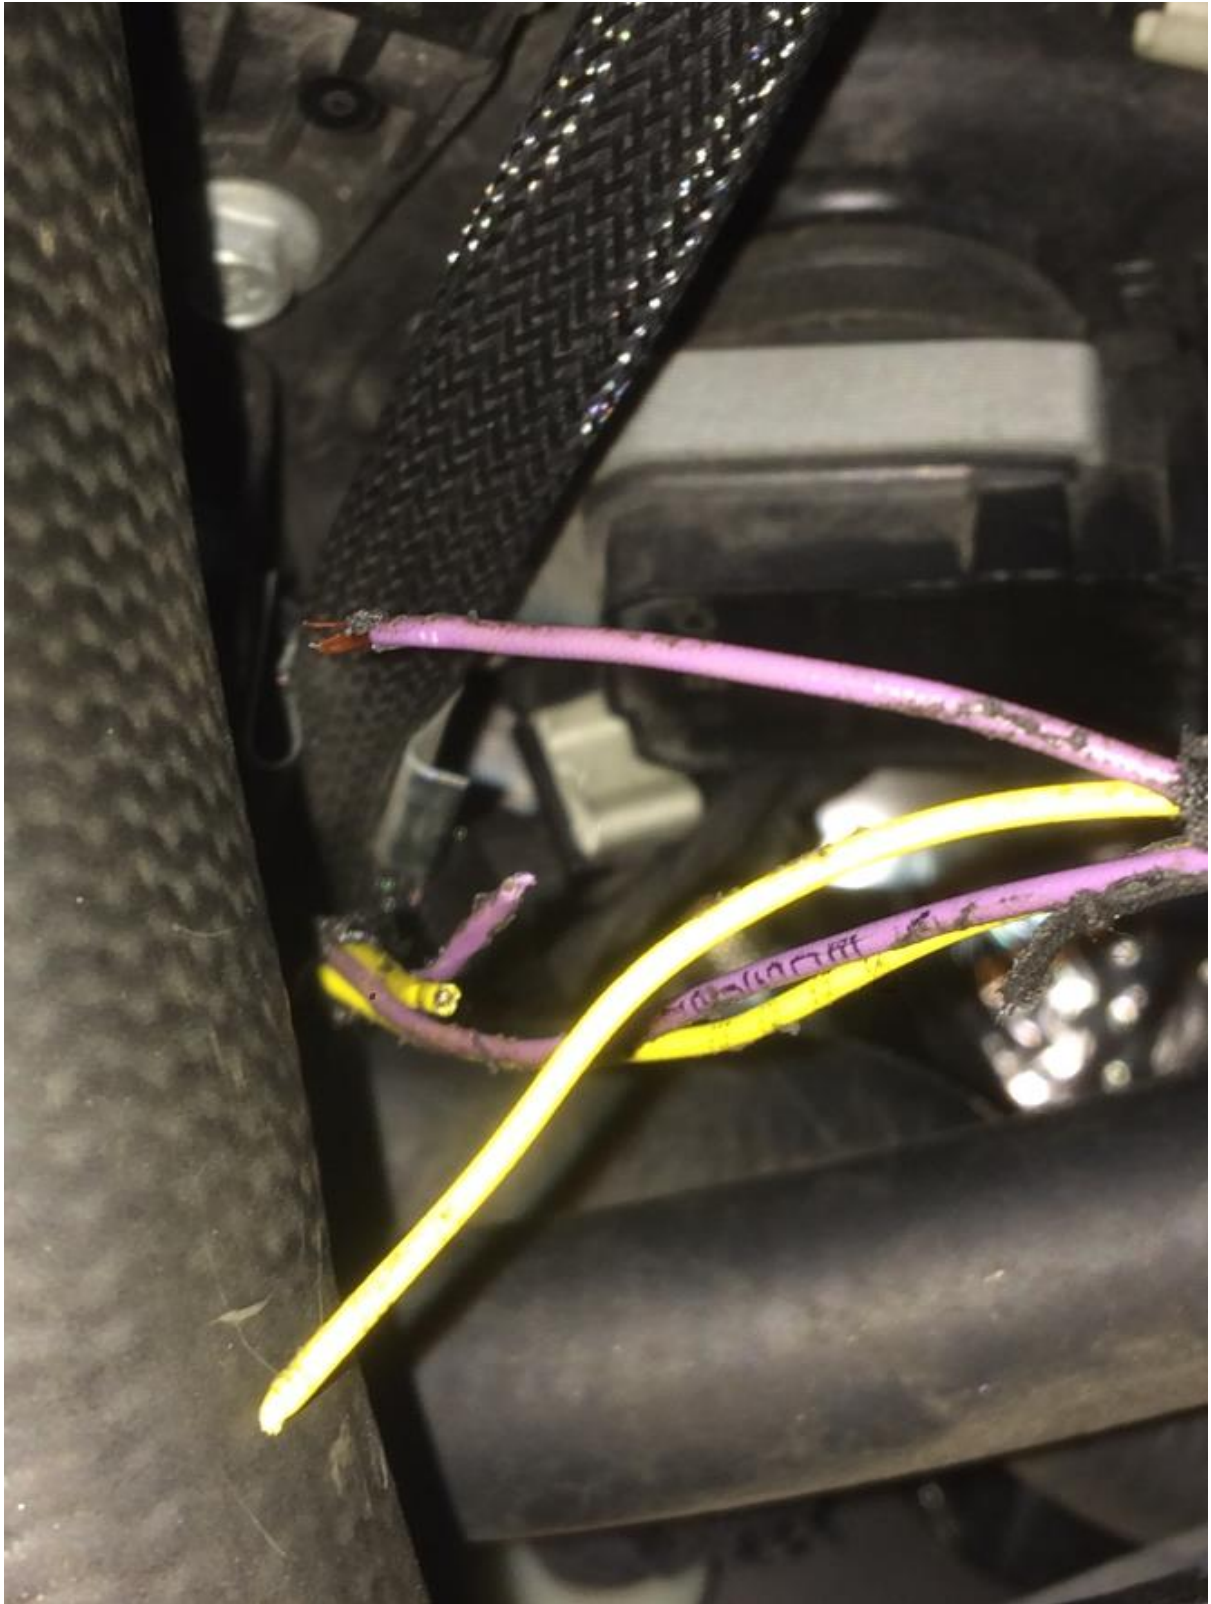
It has been identified that incorrect fitment of cable ties that secure the engine wiring harness along the cylinder head covers can damage the wiring internally.

Examples of engine wiring harness damage:

If any damage in the wiring is identified please proceed and repair the affected wiring as per SIS instruction.
