Vibration, Noise from Engine Bay Area

Powertrain Systems – Powetrain Mounting System – P11: 650S, 625C, 650S Spider, 675LT, 675LT Spider, P12: P1, P13: 570S, 570GT, 570S Spider, 540C, 600LT, 600LT Spider, P14: 720S, 720S Spider, P15: Senna. Refer to the document if noise is present inside the cabin that is originated from rear end of the car

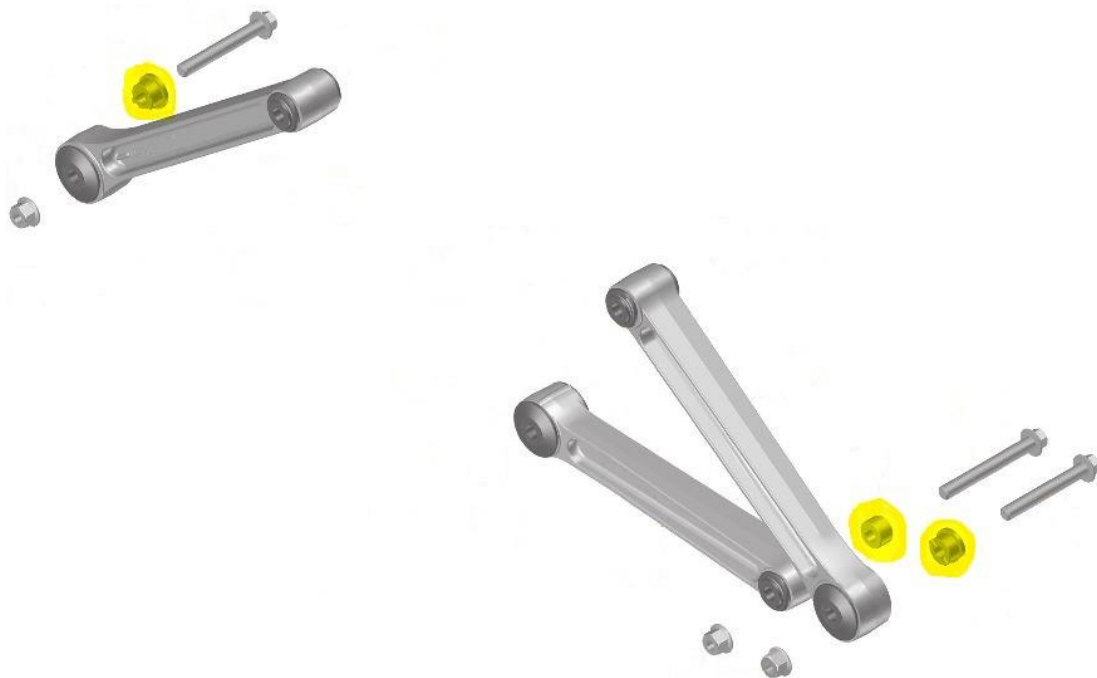
Use chassis ear to identify which (if any) of the engine mount bushes are noise.

The bushes/spacers are highlighted below.

If is confirmed that the spacer is the cause of the noise, remove the retaining bolt and check if the spacer is loose fitting in the engine frame as per the video below.

If the spacer is found to be loose, it should be replaced with the revised part number. Refer to the Parts section of the document for the correct part number.

14FA290CP – Spacer Engine Mount Locator
