Location: Electrical – Window Lift

Concern: Window Anti-Trap poor behaviour

Condition: When raising window or closing door the window's Anti-Trap feature is enabled

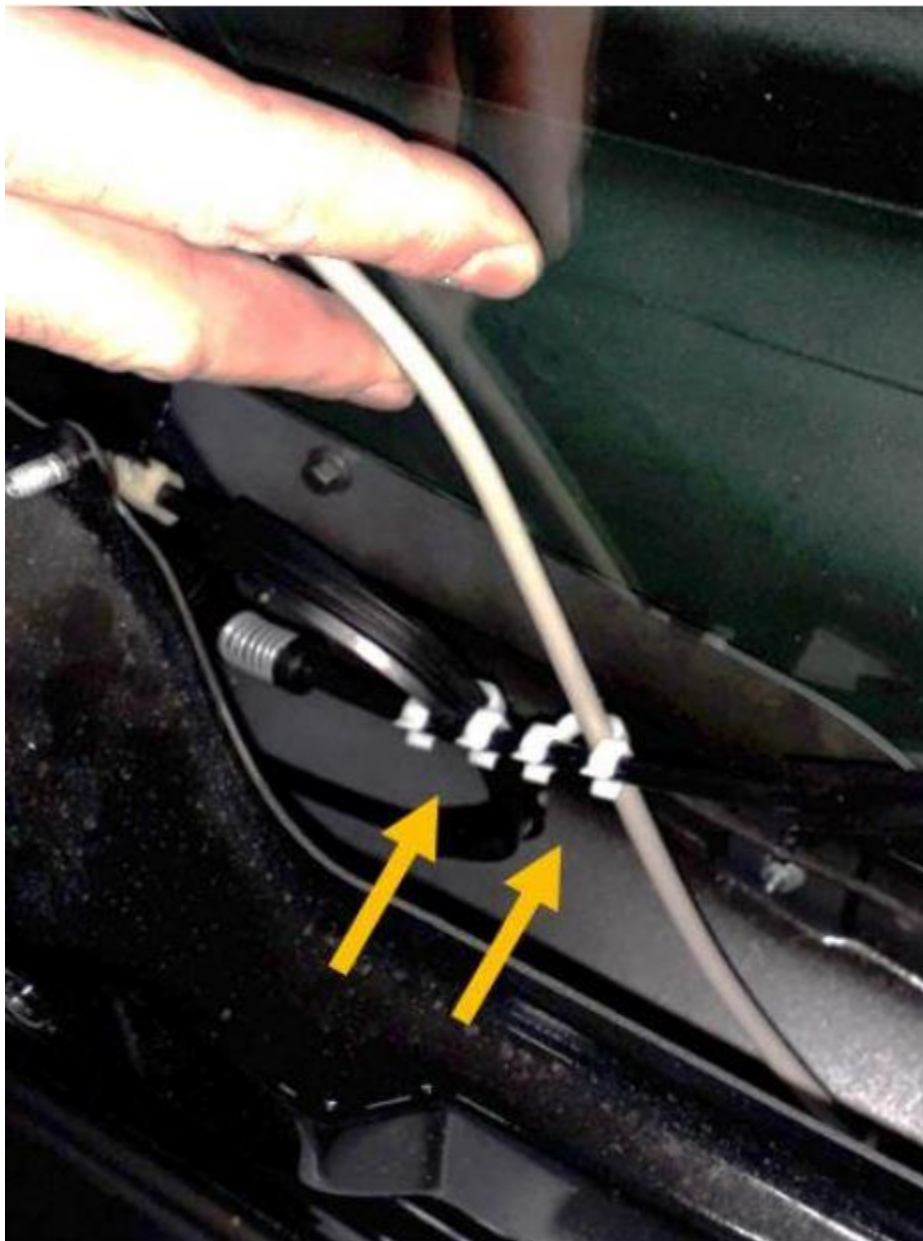
If window anti-trap is still encountered, the securing of the drive cables should be checked. If they are not secured, or secured using a cable tie, the motion of the window regulator will not be uniform during raising and the speed will slow. This will encourage premature anti-trap intervention. Please use part 00RB250 X2 and install as illustrated in the picture below.
