Vehicles affected: P13: 570S, 570GT, 570S Spider, 540C

Location: Interior – Interior Systems

Concern: Lack of seat backrest movement/adjustment while the motor is still working

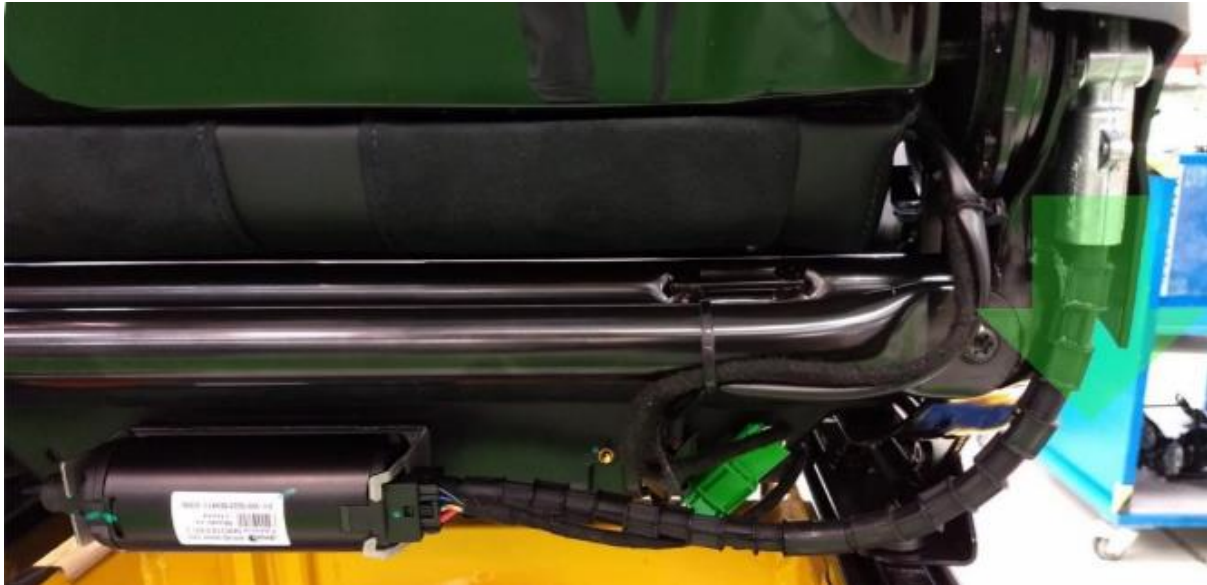
1. Remove the seat from the vehicle
2. Locate the seat recliner motor at the back of the seat towards the bottom as shown below

3. Remove the Bowden cable from the backrest drive gear mechanism located on the side of the seat behind a plastic cover – pull Bowden cable downwards to release as shown above
4. Disconnect the seat recliner motor electrical connector
5. Carefully bend the retaining brackets open to release the seat recliner motor
6. Remove the seat recliner motor with the Bowden cable
7. Free up the Bowden cable and separate from the seat recliner motor
8. Confirm Bowden cable failure
9. If the Bowden cable is found to be damaged, remove any cable fragments from the motor and/or the backrest drive gear mechanism (see example image below)

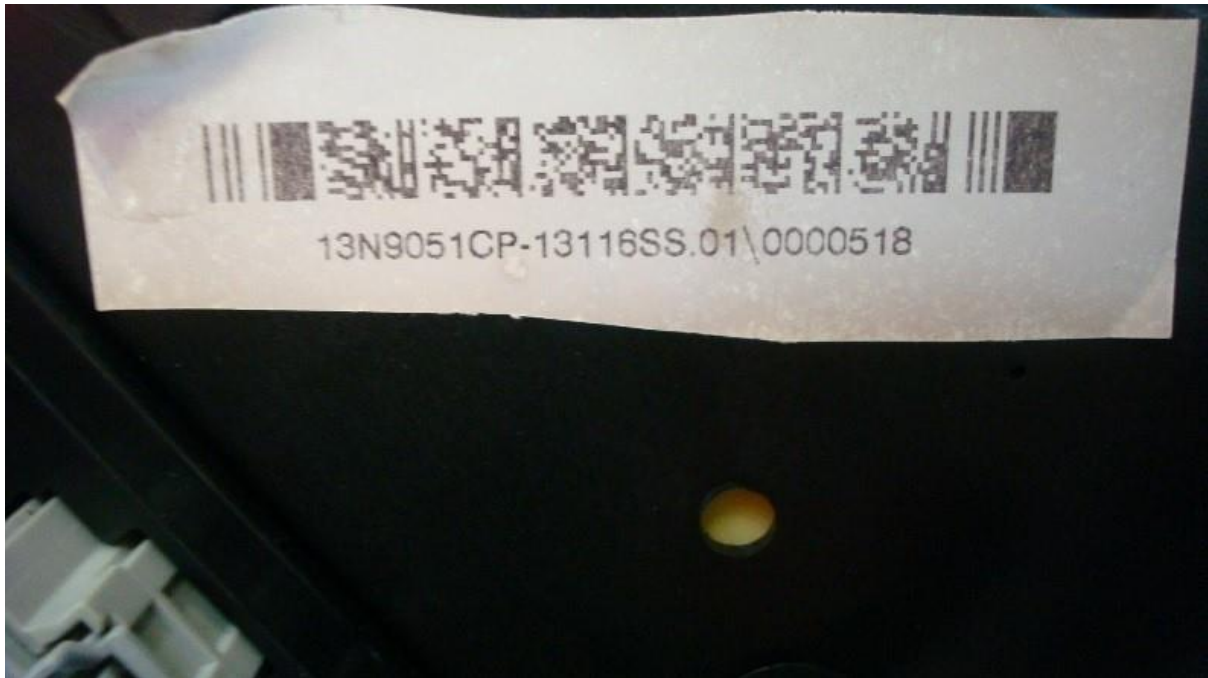
Ensure a photo of the seat serial number is saved in the work package - see example image below.
