Vehicles affected: All Models

Location: Chassis – Suspension

Concern: Damper Leak/Oil found around shock absorber during an inspection

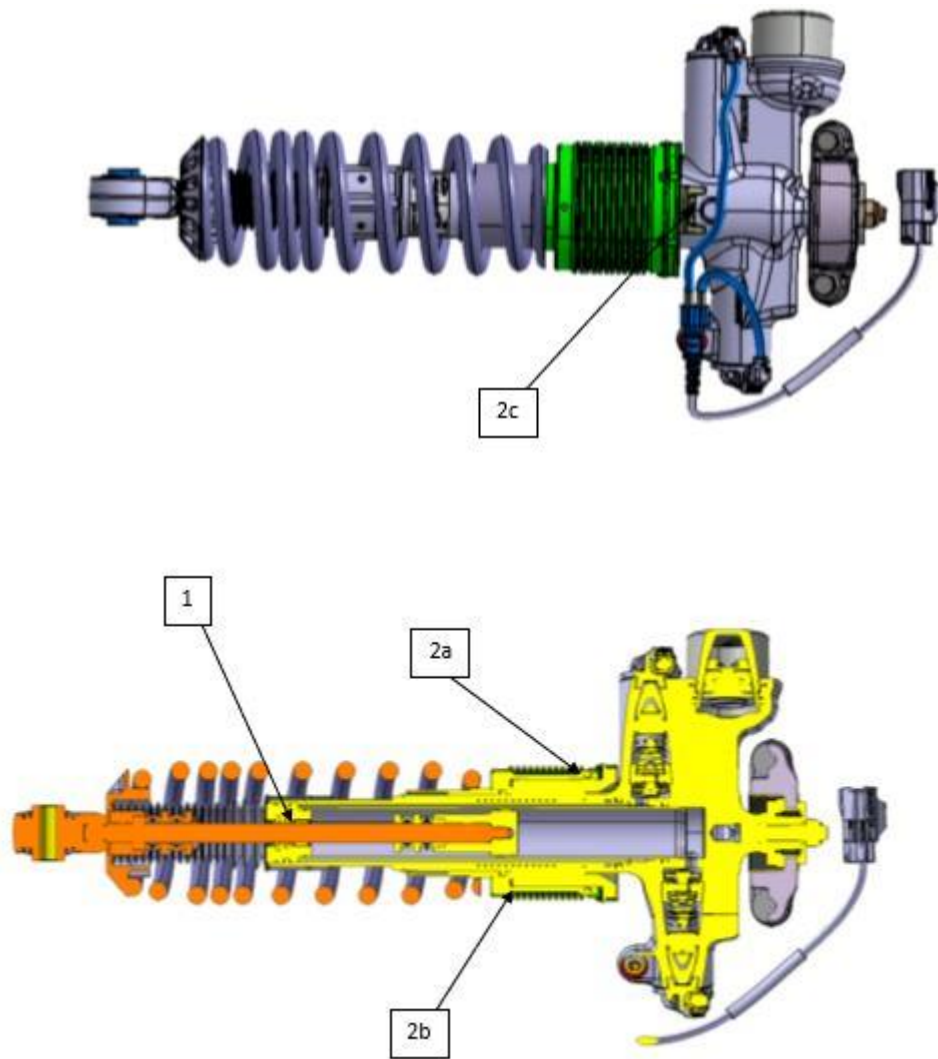
1. Rod Seal Leak

Leak propagates from the seal pack and runs down the rod before gathering at the lower spring coils. Usually identifiable by a spring that displays dirt contamination on its lower coils but is clean above this point.

2. Nose Lift Collar Leak

- a. Upper Seal – Leak propagates from the upper seal and runs down the outer lift gaiter. Usually identifiable by oil residue on the lift gaiter.
- b. Lower Seal – Leak propagates from the seal pack and runs down the damper body. Usually identifiable by oil residue on the damper gaiter.

If a leak is found, please proceed as follows:

- Take clear, well-lit and in-focus images as they will be required for any warranty claim.
- Clean any oil from affected area using suitable cleaning agents.
- Take vehicle on an assessment test drive.
- Re inspect area; If the leak has not returned, no further action is required.
- If the fluid leak is still present, the damper(s) needs to be replaced. Ensure the following information is available in the WP for warranty purposes. Failing to include this information may result in claim rejection.
 - a. Clear, well-lit and in-focus images of the before and after condition.

- b. Direction on the assumed failure, based on the failure modes identified above.
- c. Clear, well-lit and in-focus images of the label showing the part no. of the faulty damper.

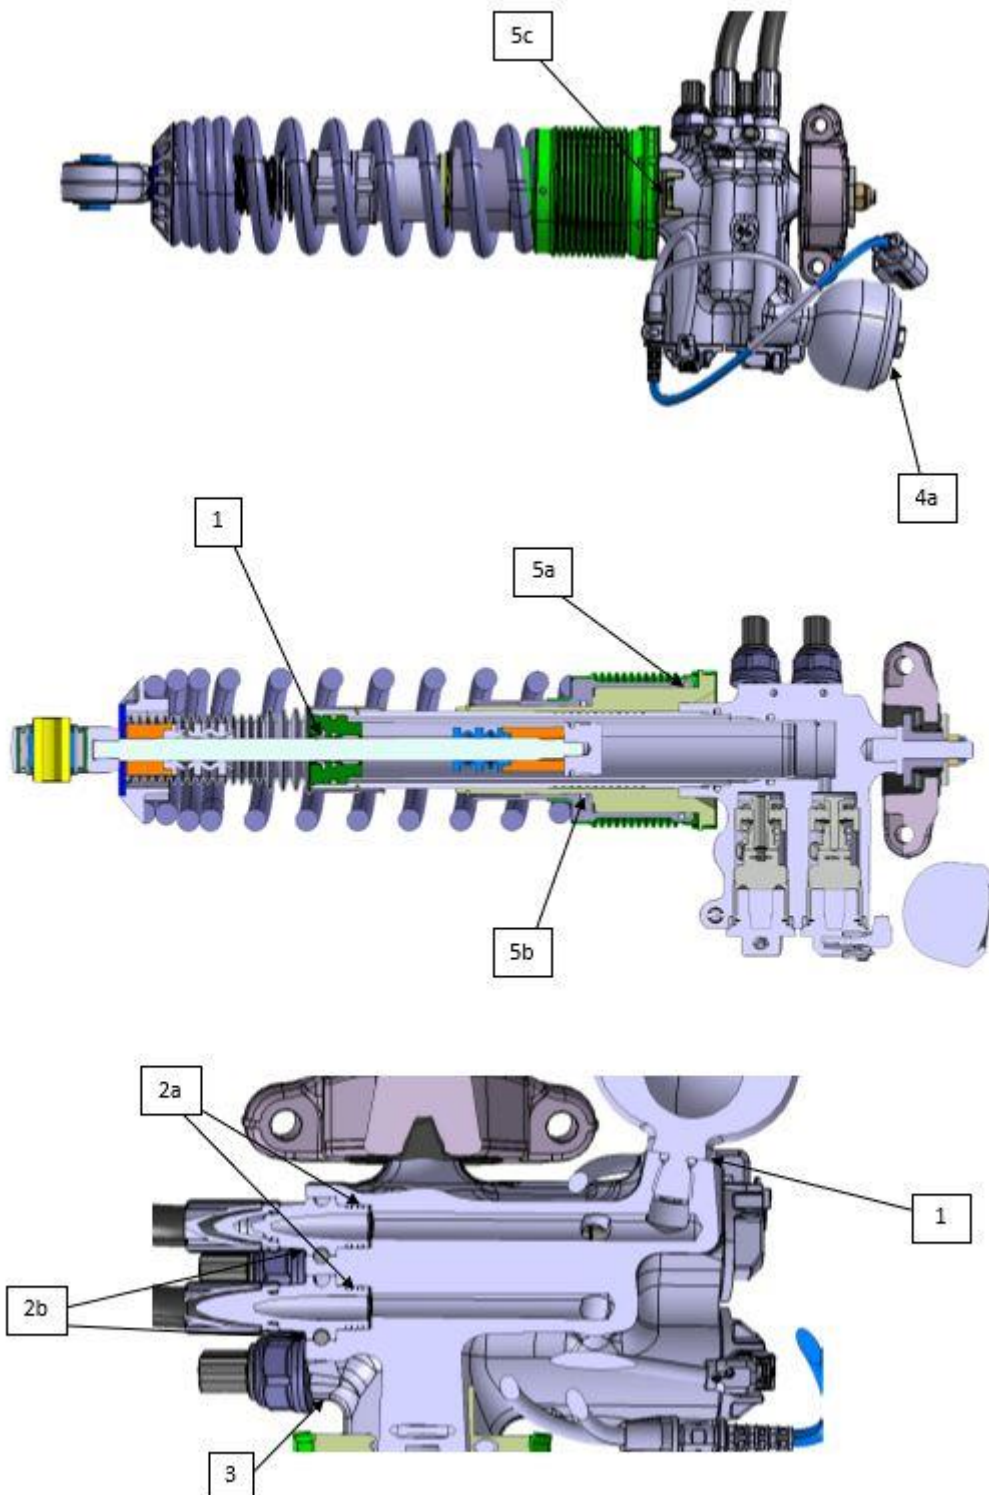
1. Rod Seal Leak

Leak propagates from the seal pack and runs down the rod before gathering at the lower spring coils. Usually identifiable by a spring that displays dirt contamination on its lower coils but is clean above this point.

2. Kinetic Line Leak

Residue between the O-Rings (2a) and Backing Plate (2b) can run down the machined surface on the damper forging. This can be wiped clean and will not return.

3. Pressure Sensor Leak

If pressure sensor is only hand tight a leak can be present. If pressure sensor torque is to target, oil residue is usually a result of a weep from the Kinetic Lines (see point 2).

4. Accumulator Leak

Oil present around either the top surface of the accumulator (4a) or around the interface with the Valve Housing forging (4b).

5. Nose Lift Collar Leak

- a. Upper Seal - Leak propagates from the upper seal and runs down the outer lift gaiter. Usually identifiable by oil residue on the lift gaiter.
- b. Lower Seal - Leak propagates from the seal pack and runs down the damper body. Usually identifiable by oil residue on the damper gaiter.

- c. Banjo Fitting - Leak propagates from the banjo/lift block interface. Usually identifiable by oil residue running down the front of the lift gaiter from the banjo fitting.

If a leak is found, please proceed as follows:

- Take clear, well-lit and in-focus images as they will be required for any warranty claim.
- Clean any oil from affected area using suitable cleaning agents.
- Take vehicle on an assessment test drive.
- Re inspect area; If the leak has not returned, no further action is required.
- If the fluid leak is still present, the damper(s) needs to be replaced. Ensure the following information is available in the WP for warranty purposes. Failing to include this information may result in claim rejection.
 - a. Clear, well-lit and in-focus images of the before and after condition.
 - b. Direction on the assumed failure, based on the failure modes identified above.
 - c. Clear, well-lit and in-focus images of the label showing the part no. of the faulty damper.

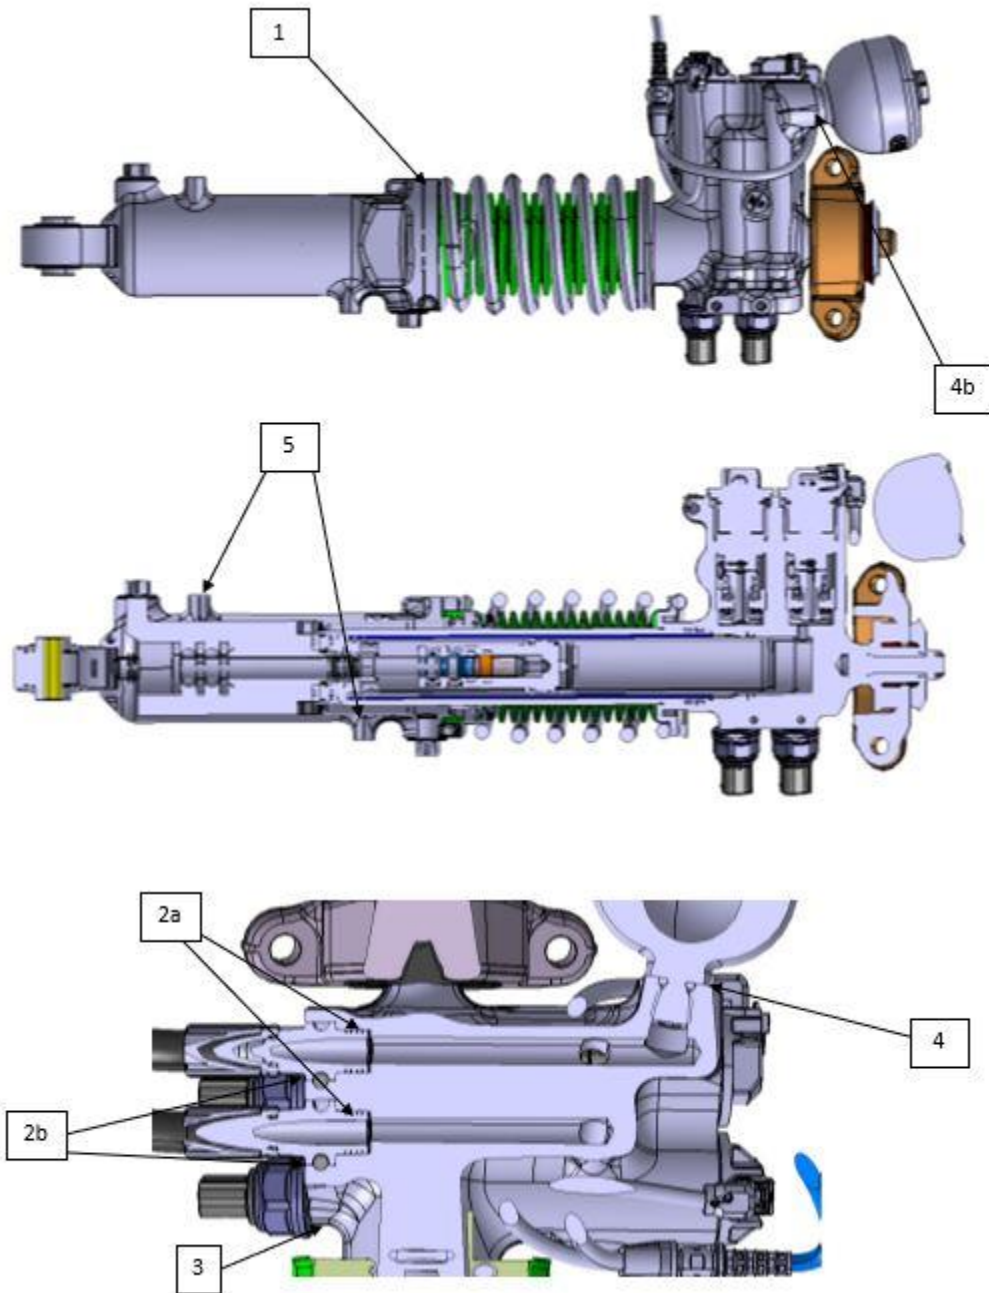
1. Rod Seal Leak

Leak propagates from the seal pack and runs down the heave body. Usually identifiable by a discolouration of the heave body.

2. Kinetic Line Leak

Residue between the O-Rings (2a) and Backing Plate (2b) can run down the machined surface on the damper forging. This can be wiped clean and will not return.

3. Pressure Sensor Leak

If pressure sensor is only hand tight a leak can be present. If pressure sensor torque is to target, oil residue is usually a result of a weep from the Kinetic Lines (see point 2).

4. Accumulator Leak

Oil present around either the top surface of the accumulator (4a) or around the interface with the Valve Housing forging (4b).

5. Heave Circuit Banjo Fitting.

6. Oil leak from the banjo connections, usually a function of an incorrectly torque fastener.

If a leak is found, please proceed as follows:

- Take clear, well-lit and in-focus images as they will be required for any warranty claim.
- Clean any oil from affected area using suitable cleaning agents.
- Take vehicle on an assessment test drive.
- Re inspect area; If the leak has not returned, no further action is required.

- If the fluid leak is still present, the damper(s) needs to be replaced. Ensure the following information is available in the WP for warranty purposes. Failing to include this information may result in claim rejection.
 - a. Clear, well-lit and in-focus images of the before and after condition.
 - b. Direction on the assumed failure, based on the failure modes identified above.
 - c. Clear, well-lit and in-focus images of the label showing the part no. of the faulty damper.
