SERVICE CAMPAIGN BULLETIN

TITLE:	Front Subframe Bolt Replacement
CAMPAIGN REFERENCE	043
DOCUMENT NUMBER:	13 A 002
AFFECTED VEHICLES:	Sports Series
SITUATION:	Quality Engineering at McLaren Automotive require the front subframe bolts to be replaced due to the bolt 00RA534 coating being incorrect and causing degradation in the earthing circuit over time.
PROCEDURE:	This rework must be completed on all vehicles at PDI or before the handover of a new vehicle to a customer.

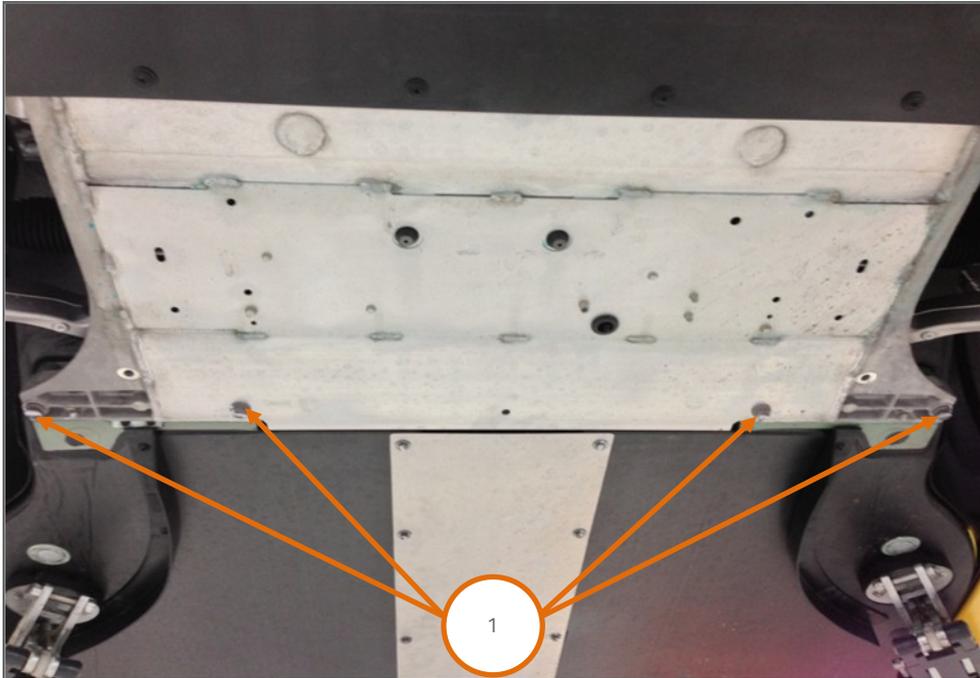
1. Please refer to CA-RM-01A001-00-001 - Secure/Lift vehicle on platform.
2. Locate the four rear mounting bolts for the front subframe (1).

3. Remove one bolt and install new bolt 11A9786CP and torque M10 x 85 to 50 Nm.
4. Repeat step 3 with the three remaining bolts.
5. Then torque all four bolts to 70Nm.
