SERVICE CAMPAIGN BULLETIN

TITLE:	Vehicle Software Update to Platform 6.2
CAMPAIGN REFERENCE:	04D
DOCUMENT NUMBER:	13 M 010
AFFECTED VEHICLES:	Sports Series
SITUATION:	<p>McLaren Automotive have released a new software platform for Sports Series vehicles.</p> <p>The customer improvements included in this software update are:</p> <ul style="list-style-type: none">• Heating Ventilation and Air-Conditioning (HVAC) flutter reduced.• Changes to the battery management strategy.
PROCEDURE:	<p>This software update must be completed on all vehicles within your Aftersales car parc, when carrying out Pre-Delivery Inspections (PDI) or at the next service centre visit.</p>

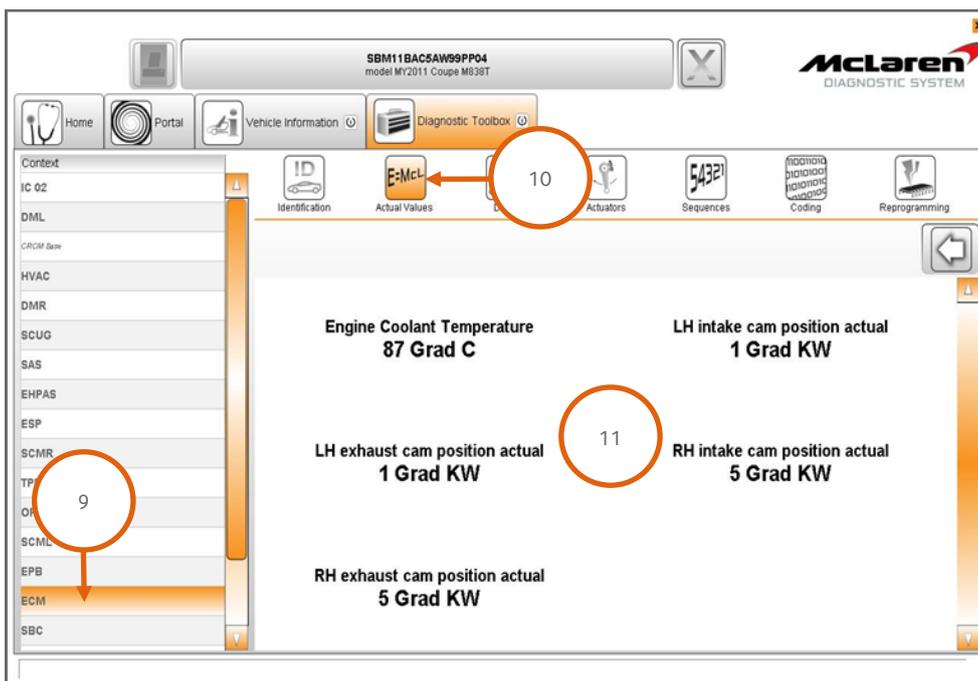
24. The inlet camshaft values should be between 9 and 12 and exhaust values should be between -9 and -12 both values will fluctuate slightly. If all values are correct no further action is required, proceed to step 26. If any values are incorrect proceed to step 25 to carry out the camshaft adaption.

23. Select ECM (9), then Actual Values (10), select the following values as per the screenshot below (11), then select the play button to access the required data screen.

25. Switch the engine off, wait 30 seconds, restart the engine and recheck the values. Repeat this procedure until the target values are achieved.
