SERVICE CAMPAIGN BULLETIN

TITLE:	Passenger Footrest Bolts Installation
CAMPAIGN REFERENCE:	03S
DOCUMENT NUMBER:	13 N 001
AFFECTED VEHICLES:	McLaren 570S
SITUATION:	Quality Engineering at McLaren Automotive have identified that a number of McLaren vehicles have left production with two top fixing bolts missing from the passenger footrest.
PROCEDURE:	Please follow the instructions outlined in this document to install the bolts to the passenger footrest.

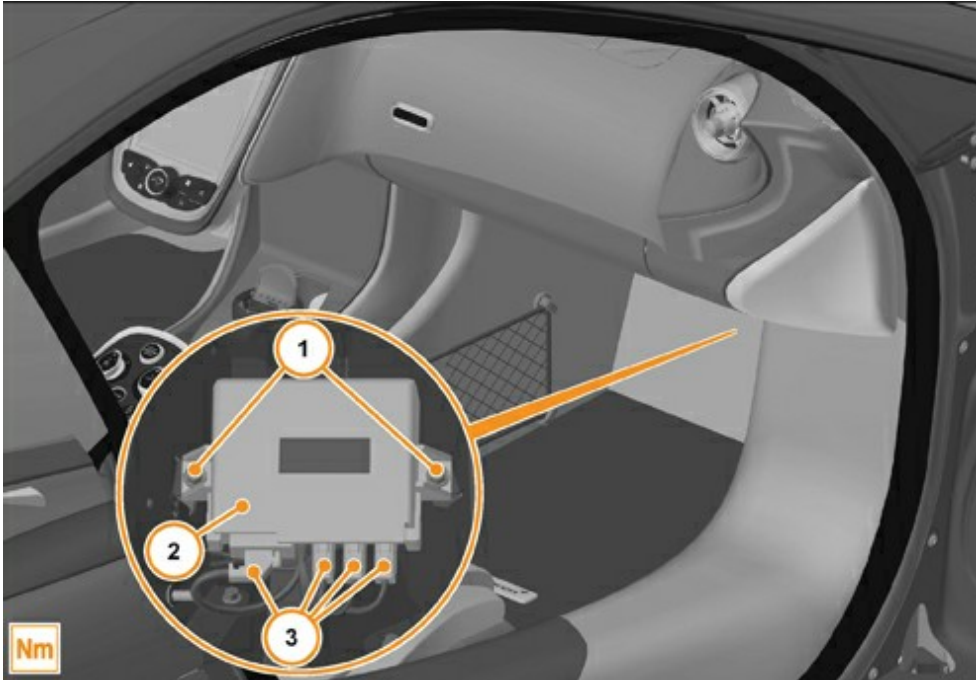
Care Point: Vehicles fitted with satellite tracker module please remove the fixing bolts (1) and lower the module to allow access at the back.
