**Location:** Powertrain Transmission – Rear Axle

**Topic:** Clutch oil leak from the SAV block

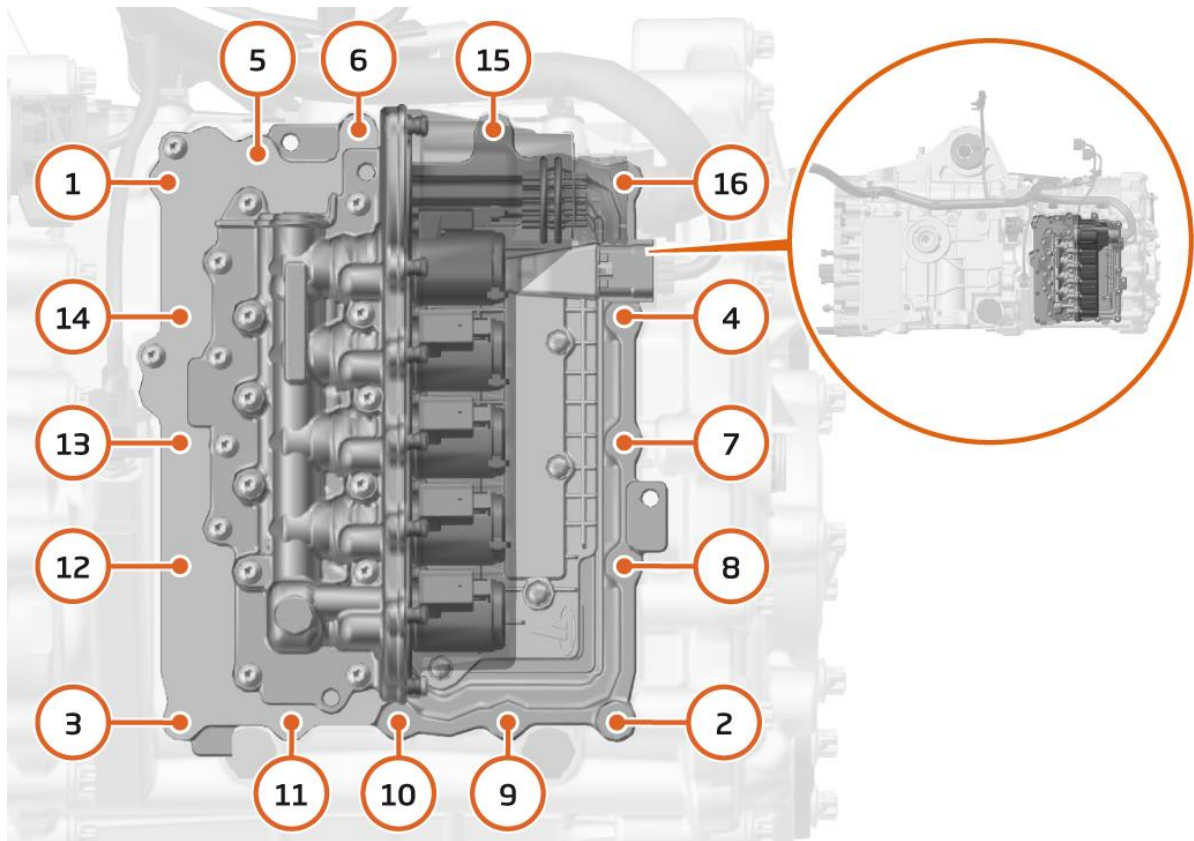
**Care Point:** Ensure the sequence (1 - 10) demonstrated in the image below is followed when removing / installing the SAV bolts.

4. Remove the SAV block bolts **one at a time** and apply Loctite 242 around the thread.
5. Re-install each bolt before the next one is removed and apply torque 10 Nm.
6. Once the above steps are completed, check the clutch and transmission oil level and top-up if required.
7. Perform a test drive until the engine and transmission are in operating temperature.
8. Return to the workshop and check for further leaks.
9. If no leak is present, no further action is required.
10. If the leak is still present from SAV block, capture some new photos of the leak.
