Location: Powertrain Systems - HVAC

Concern: Water ingress into the passenger or driver foot area

Condition: Mainly when HVAC system is in operation

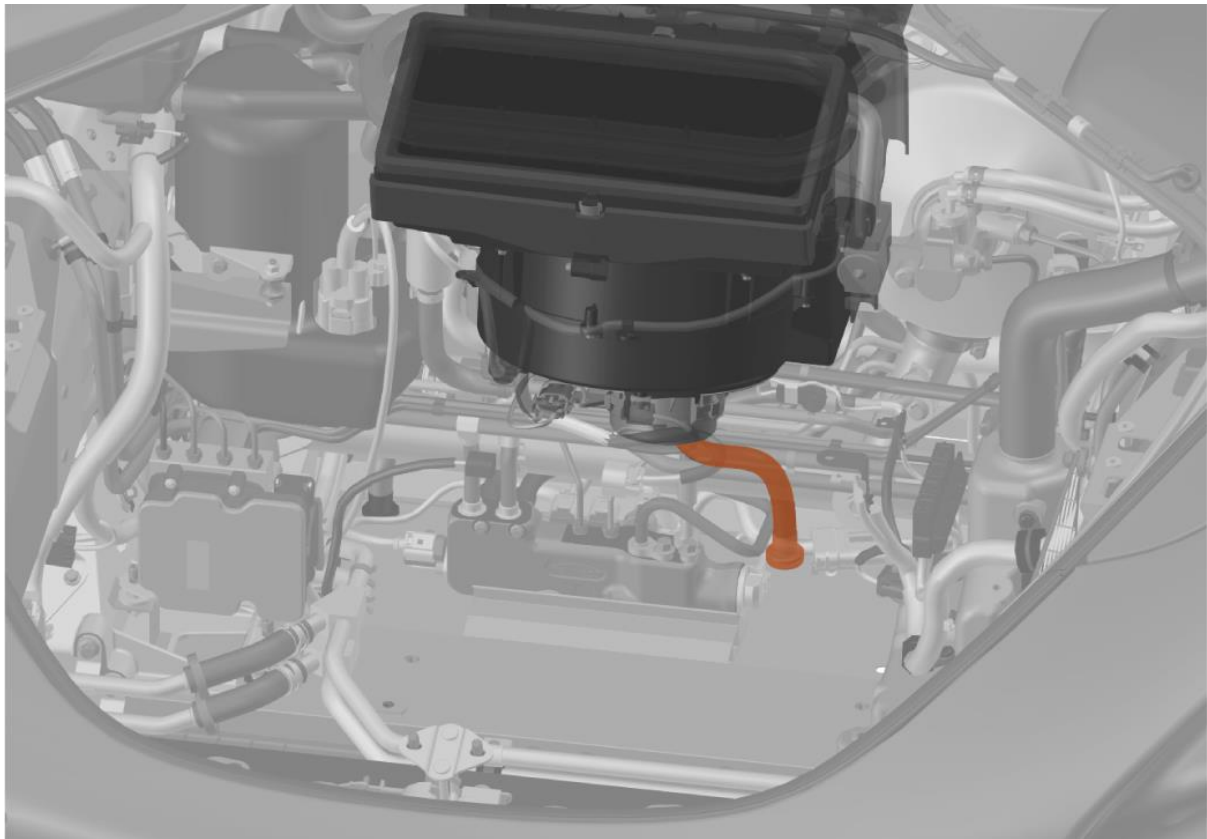
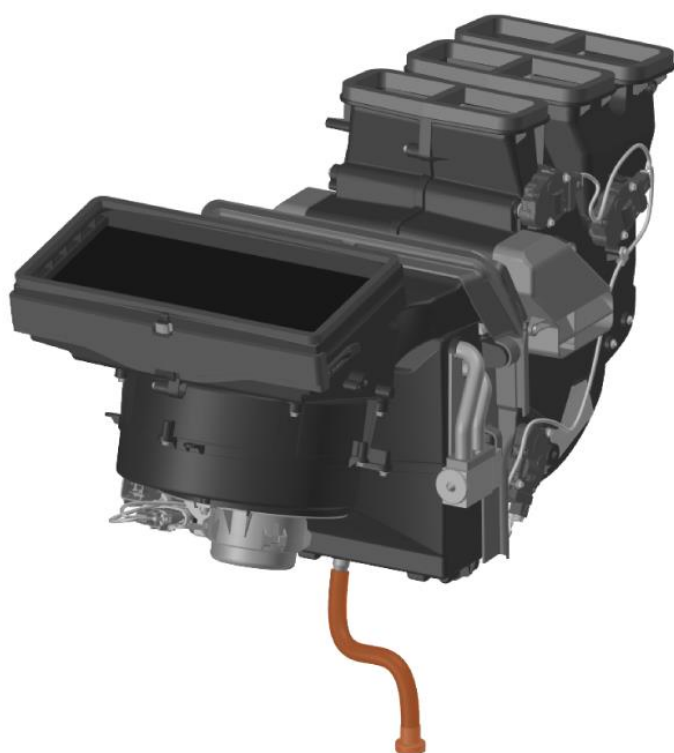
Attachments

Once you have better access to the HVAC distribution box, locate the HVAC drain hose (see pictures in the attachments area) and remove it from the spigot that is attached to the HVAC distribution box.

If presence of water is found in the driver's or passenger's foot area, the water is most likely coming from the HVAC distribution box and its HVAC drain hose. To stop the water leak, the HVAC drain hose must be removed.

Care Point: There is no need to remove the spigot.

With the HVAC drain hose removed, the drain water from the HVAC will not be directed to the cabin but it will still exit the car from an area that is designed to be wet.
