Vehicles affected: P13: 570S, 570GT, 570S Spider, 540C, 600LT, 600LT Spider.

Location: Body Exterior – Closures Ancillaries

- Alarm is going off for no reason when the car is left locked
- Unable to open door from exterior or interior door switch

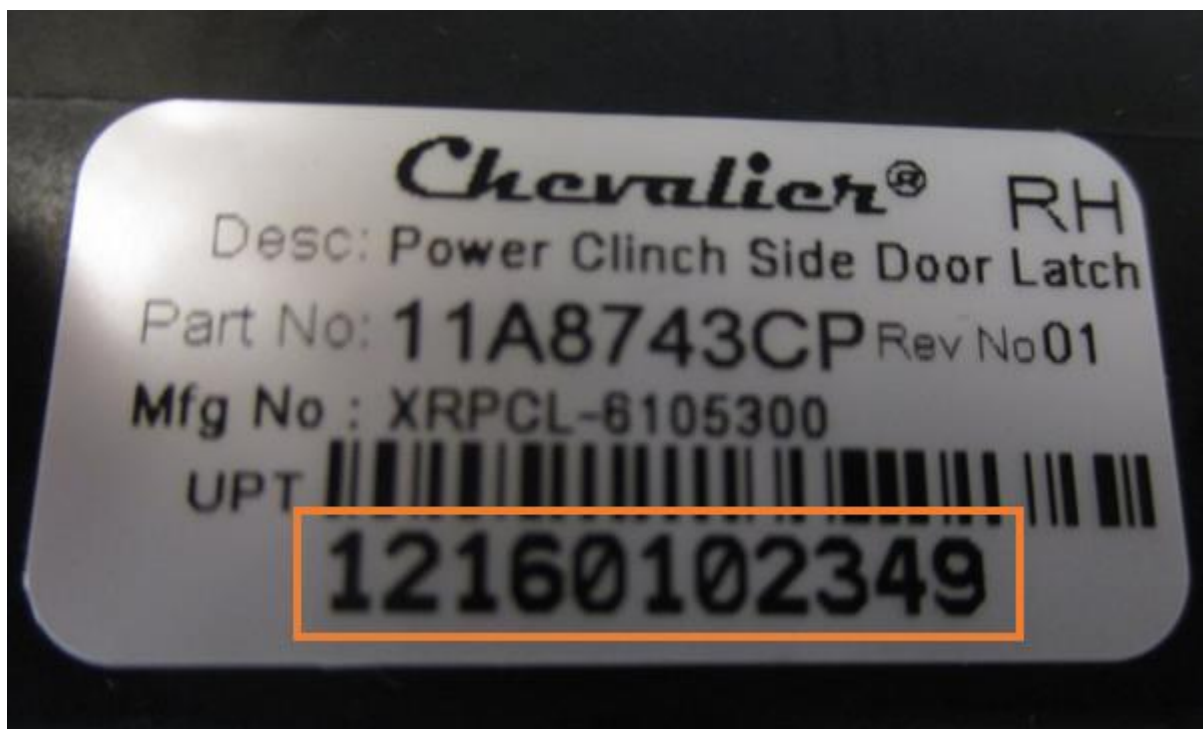
The serial number of the door latch is visible on the label of the part, see below image;

**Care Point:** Before fitment ensure the both door latches are outside of the following serial numbers ranges. This check must be done on door latches that were on your stock or received from Unipart. If a door latch is within this range, do not install and order a new one.
