Location: Powertrain Transmission – Rear Axle

Topic: Clutch oil leak between the clutch and gearbox casings

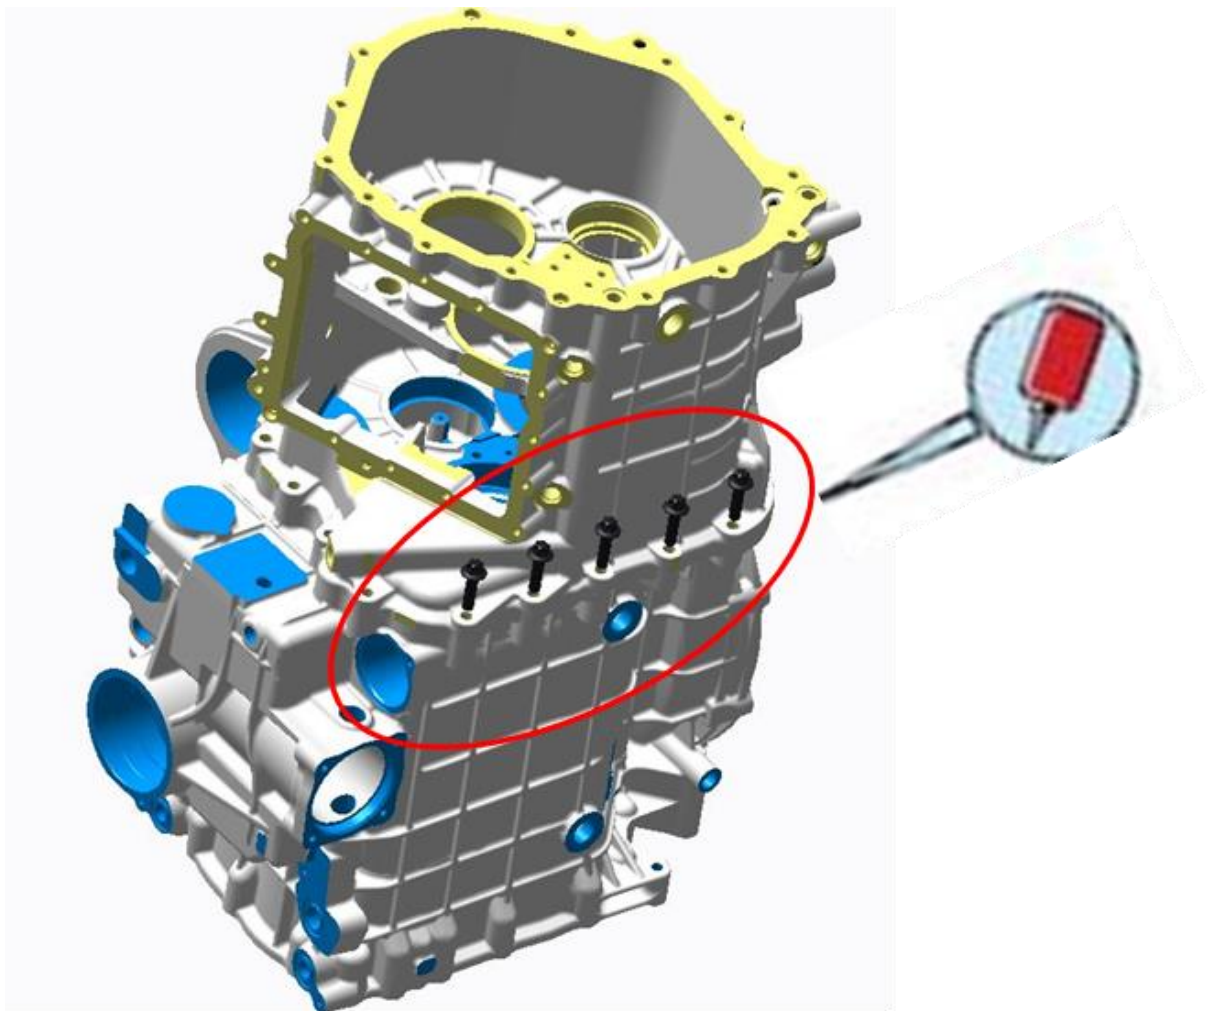
Note: A leak between the clutch and transmission casings may be due to porosity in the threaded holes.

1. Capture images of the area with the leak
2. Clean up and dry the transmission
3. Apply leak detector spray in the area that has previously leaked
4. Bring vehicle to operating temperature (test drive if necessary)
5. Inspect the transmission to confirm the source of the leak (if still present)
6. Capture new images of the leak
7. If the leak is confirmed that is between the two casings, proceed to the next step. If no further leaks have appeared no further action is required.

8. Remove the bolts shown in the image below one at a time.

9. Clean the residual oil from the casing and the bolt
10. Apply Loctite 242 on the screw as shown below
11. Re-install the bolt and torque to 32Nm
12. Repeat the above procedure for all five bolts
13. Bring vehicle to operating temperature (test drive if necessary)
14. Inspect the transmission to confirm if the leak is still present
15. If the leak remains, please raise a Technical Request and refer to this KA.
