SERVICE CAMPAIGN BULLETIN

TITLE:	Vehicle Software Update to Platform 6
CAMPAIGN REFERENCE:	048
DOCUMENT NUMBER:	13 M 008
AFFECTED VEHICLES:	Sports Series
SITUATION:	<p>Quality Engineering at McLaren Automotive have released a new software platform for the Sports Series</p> <p>The customer improvements included in this software are:</p> <ul style="list-style-type: none">• Loss of seat calibration• Trip reset after an ignition cycle• HVAC calibration change for Coupe• HVAC logic changed for the different AC refrigerants• HVAC LO cooling improvements• FM radio reception improvements
PROCEDURE:	<p>This software update must be completed on all vehicles within your Aftersales car parc, when carrying out Pre-Delivery Inspections (PDI) or at the next service centre visit.</p>

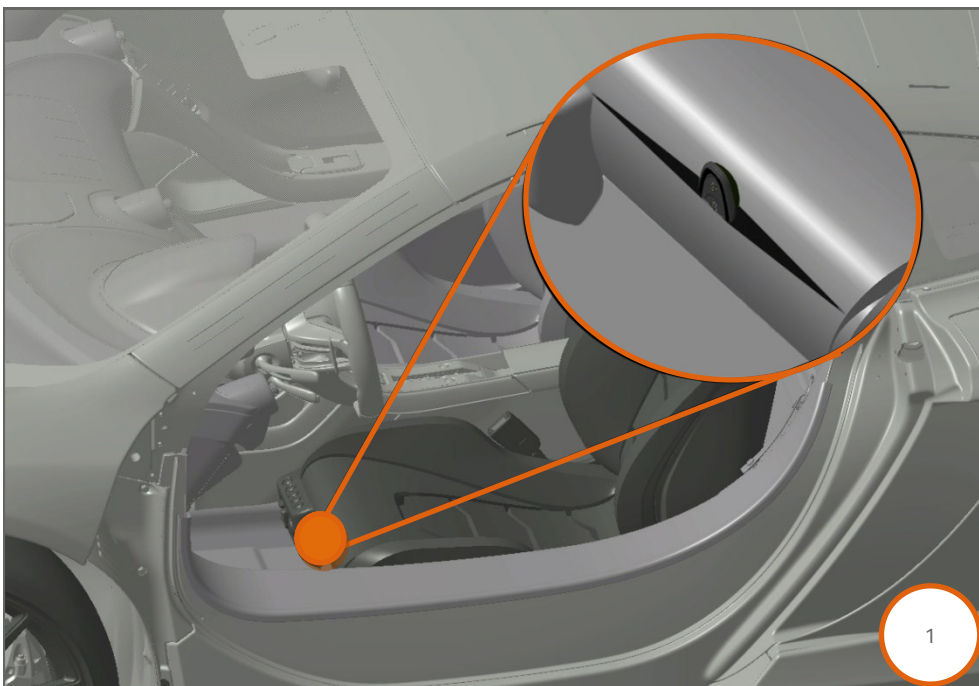
Care Point: The key must be positioned in the driver's seat front pocket (1).

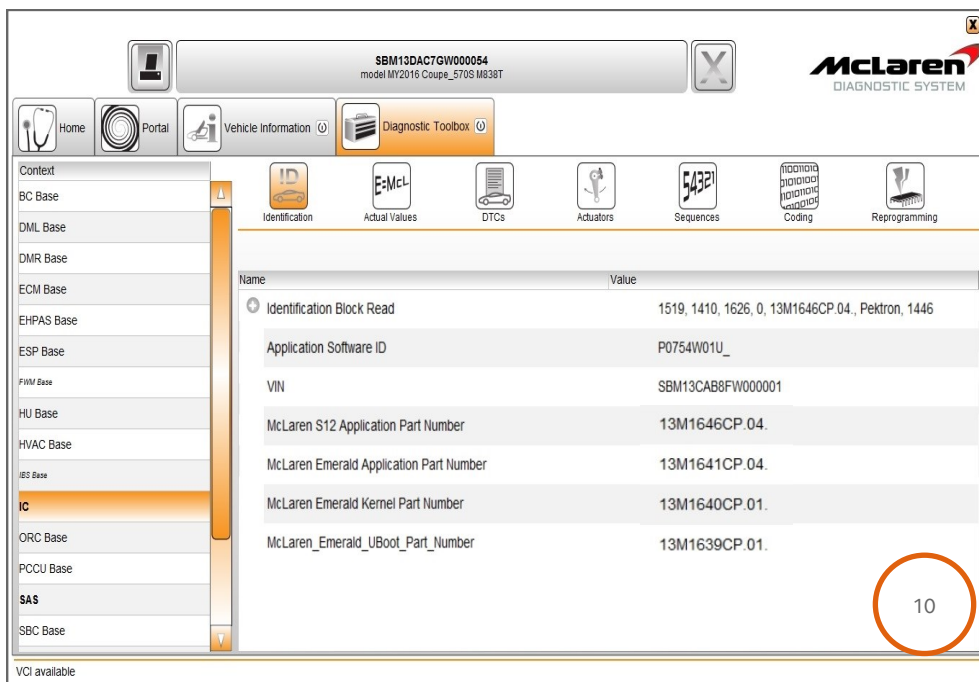
11. IC software level confirmation needs to be performed. Confirm the IC software levels are the same as the screenshot below (10). If they are the same proceed to step 12. If they are incorrect raise a Technical Request with IC software level information.

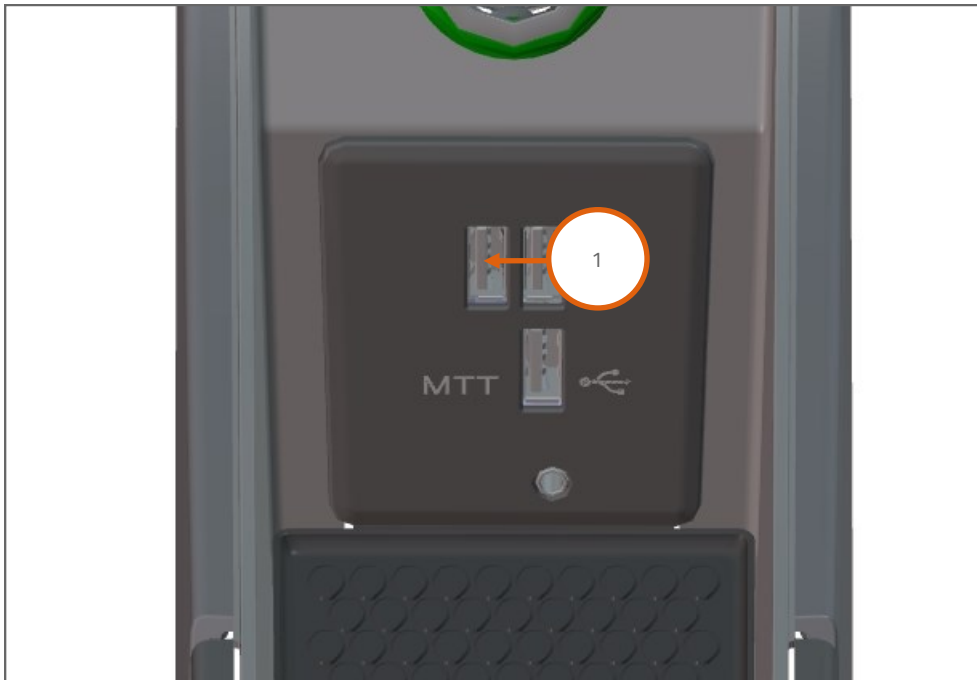
62. Switch the ignition on to ignition state 5 and start the engine.
63. Make a note of the options displayed on the Home Screen as this information will be required to configure the head unit.
64. Insert the USB drive with the application software into the USB socket (1).

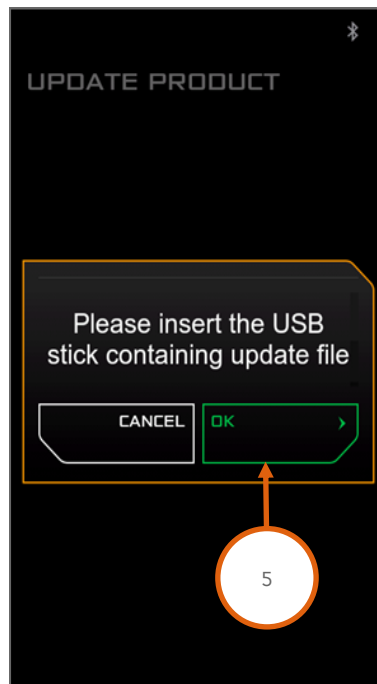
68. On the following screen select Update by USB Stick (4). A pop up message will be displayed. Press OK (5) to start the loading operation.

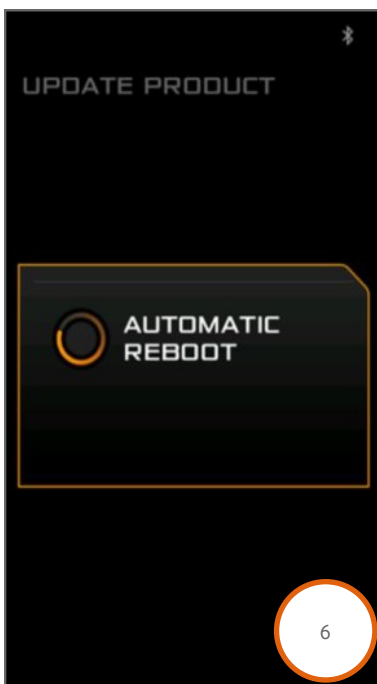
69. The following screen will be displayed (6) and the system will reboot.

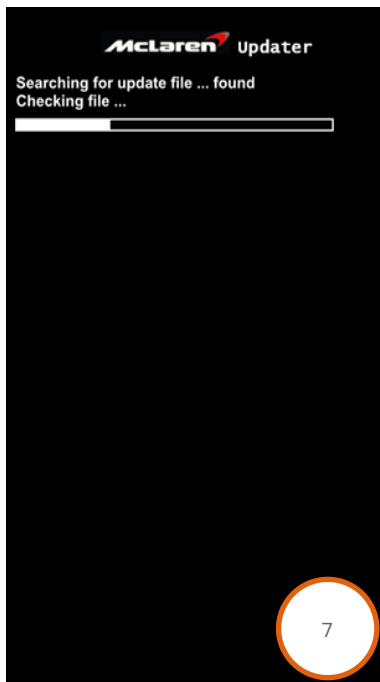
70. After the system has rebooted it will search for and check the update file (7). Once the installation has finished the following screen will be displayed (8) and the system will reboot.

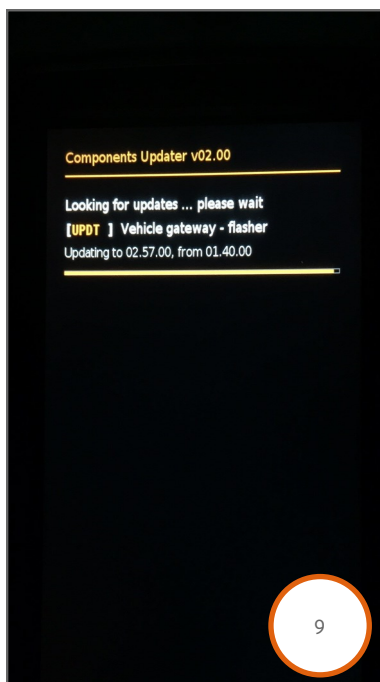
71. Following the reboot, the system will start to update the individual system components (9), (10). During the update the system may reboot multiple times. This is normal, **do not attempt a manual reset**.

Care Point: In case the system should get stuck on the update screen if one of the component updates has failed, press and hold the home button for 45s to force the system to reboot.

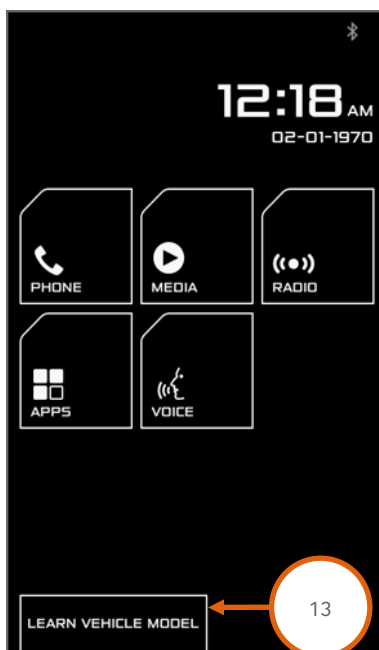
76. Select Learn Vehicle Model (13) from the Home Screen. The system will perform a configuration update and reboot. Wait until the system has fully booted to the Home screen before proceeding to the next step.
