**Location:** Engine Systems – Engine Miscellaneous

**Topic:** Lack of power and/or MIL light ON

**Condition:** Under acceleration

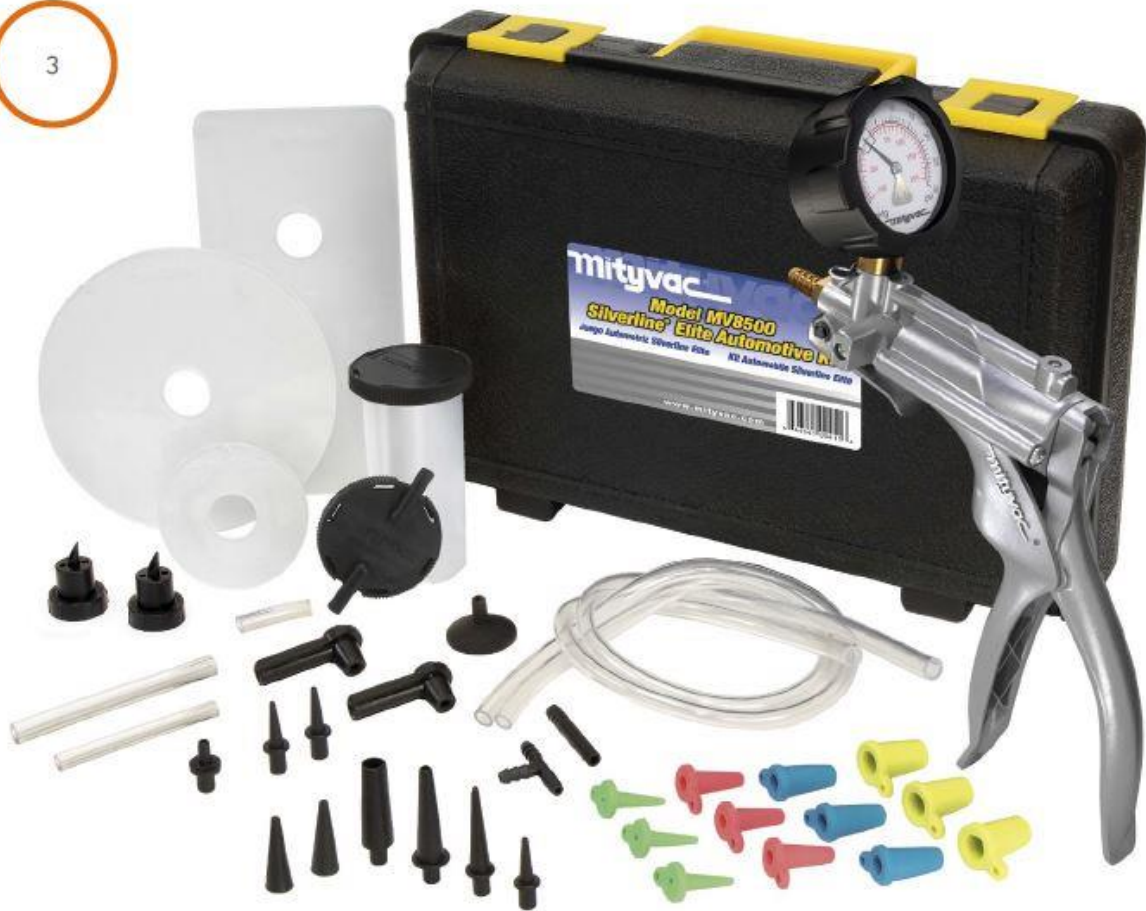
3

The tooling required is a vacuum/pressure tester, an example is shown below (3).

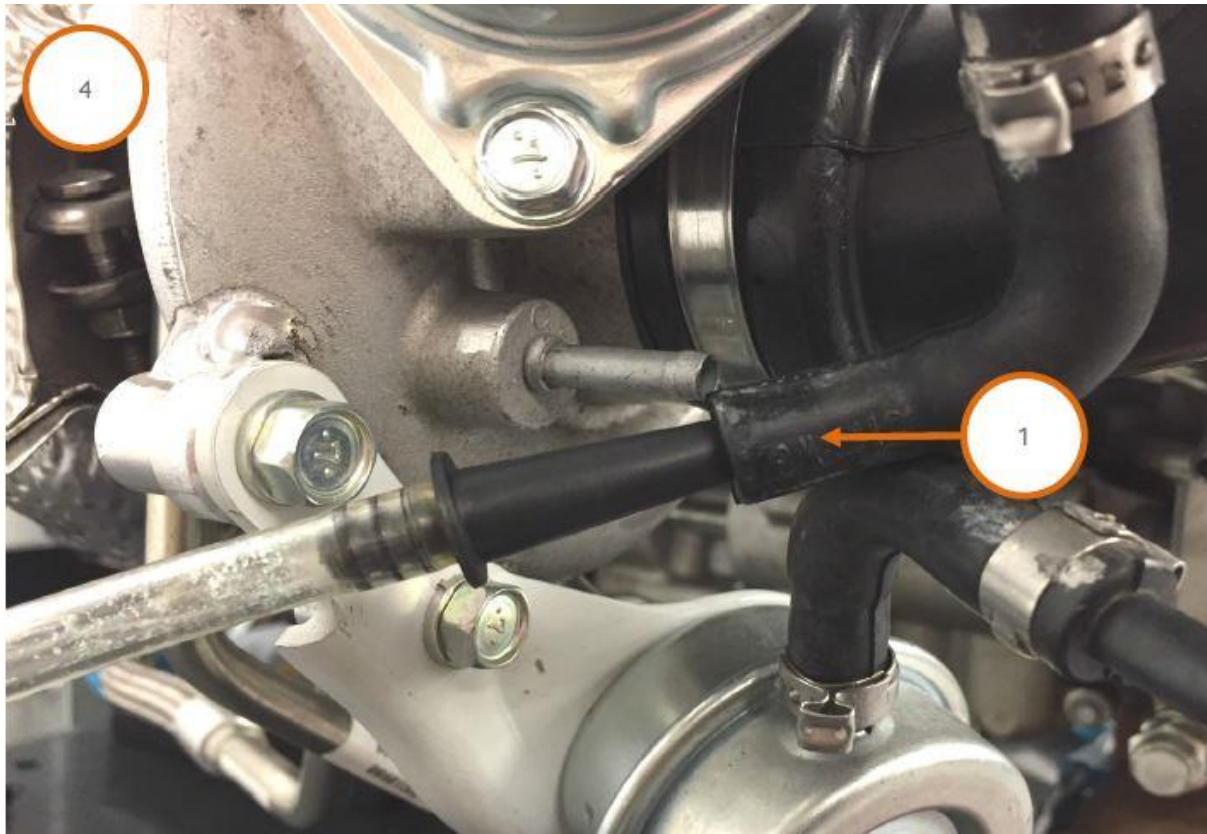
If all the connections are secure, pressure test the turbo control circuit on each bank even if only one bank has a DTC stored. Remove the 90 degree elbow (as shown on image 4 ) from each turbo, pressurise each circuit in turn up to 12 psi.

At this point there are four possible results:

1. No pressure is built up in the system - proceed to Step 3
2. Pressure builds but decays after 1 minute - proceed to Step 3
3. Pressure builds, the wastegate actuator moves and the pressure holds for more than 1 minute - proceed to Step 2
4. Pressure builds, the wastegate actuator doesn't move and the pressure holds for more than 1 minute - proceed to Step 6

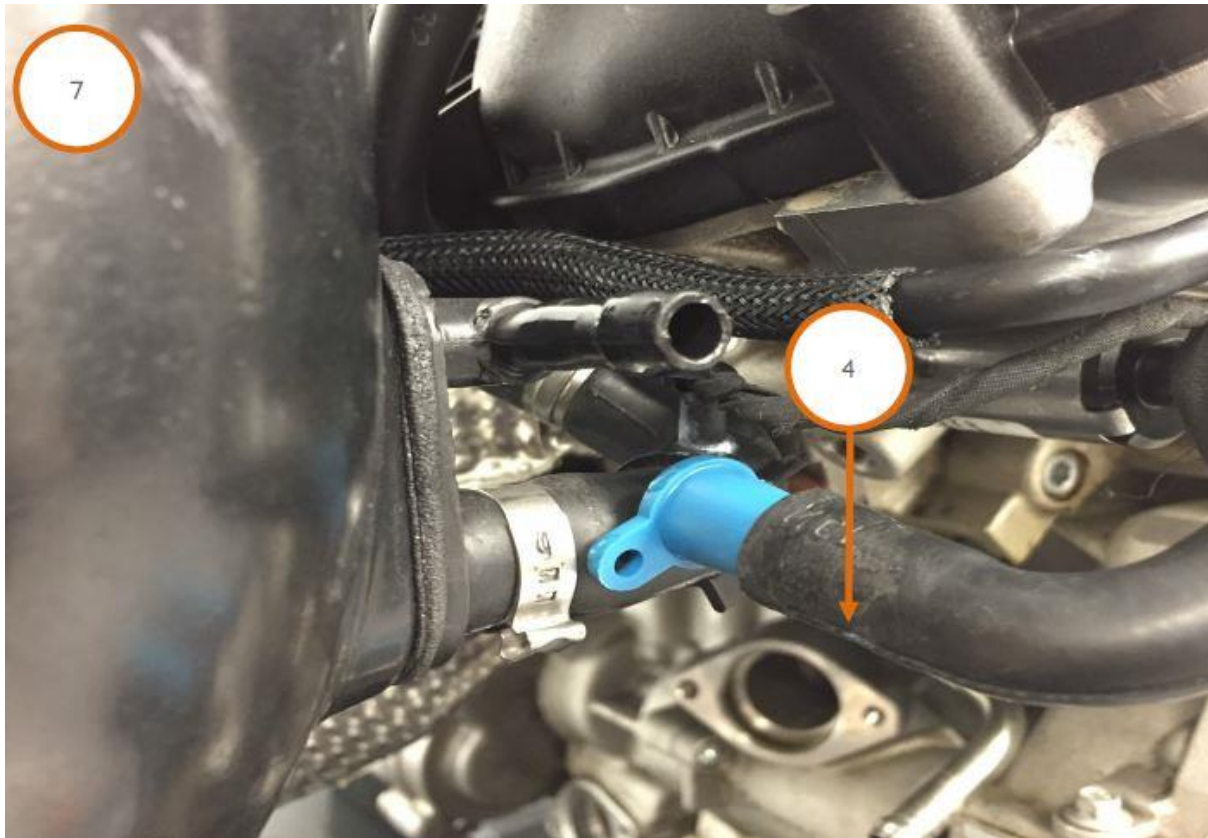
At this point if pressure does not build then the fault is with the vacuum harness.

There is another test to confirm this, detach the 90 degree vacuum harness pressure bleed pipe elbow (4) that connects to the MAF tube, blank it off. Pressurise the system, if it now builds pressure the vacuum circuit is confirmed as faulty.

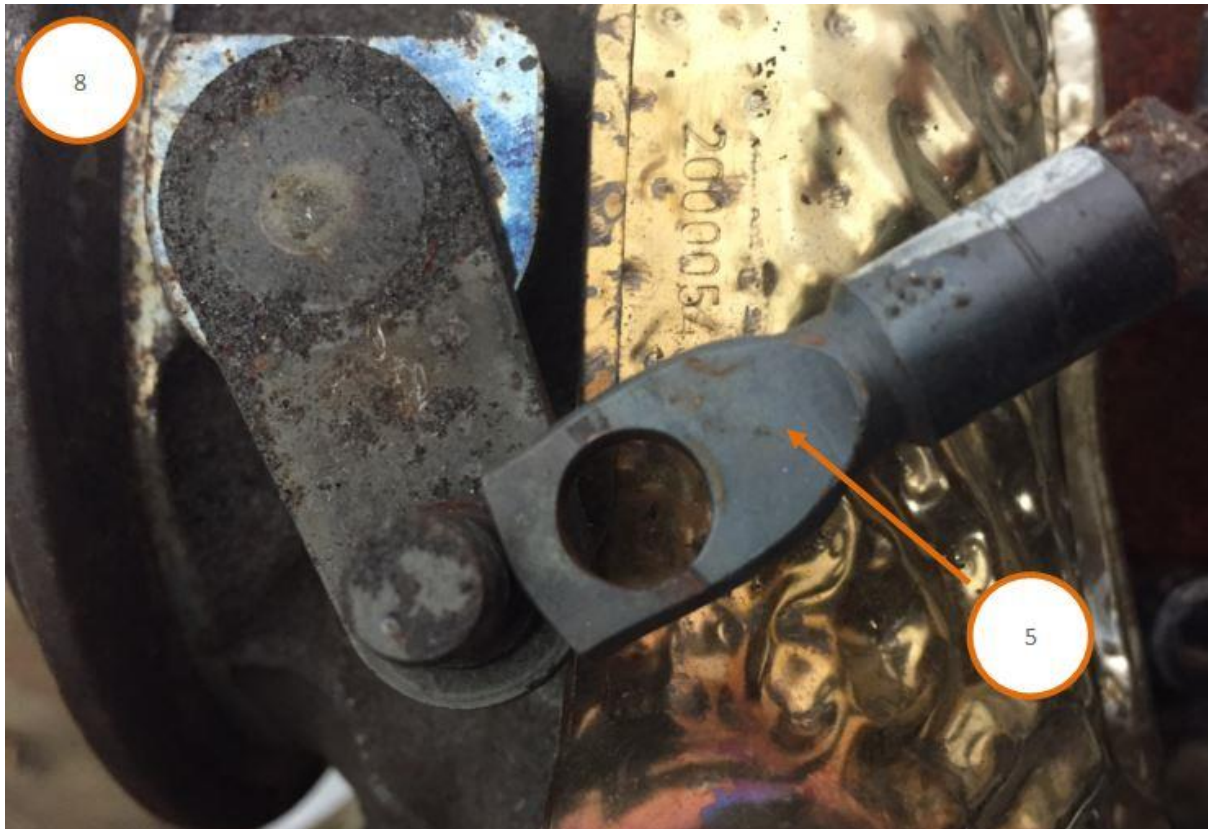
If the wastegate is not moving when the system is pressurised, the wastegate is seized. Please refer to the SIS instruction "Remove/install wastegate assembly - turbo charger" for the relevant model and follow steps to undo the turn buckle (5). Then check if the wastegate arm can be moved, it should move freely.

Care Point: Always check wastegate adjustment after any leak repair or component replacement.
