**Location:** Body Exterior – Closures Ancillaries

- Alarm is going off for no reason when the car is left locked
- Unable to open door from exterior or interior door switch

**Condition:** Randomly occurring and /or after long parking periods > 7hours

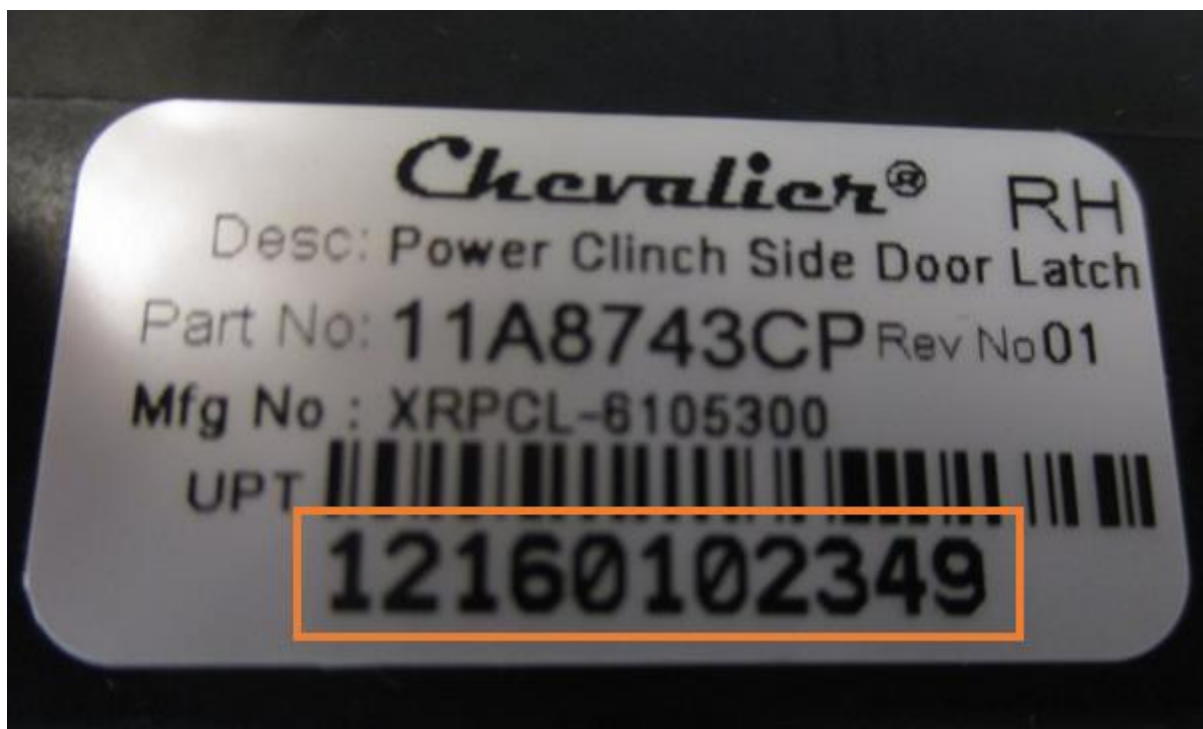
The serial number of the door latch is visible on the label of the part, see below image;

**Care Point:** Before fitment ensure the both door latches are outside of the following serial numbers ranges. This check must be done on door latches that were on your stock or received from Unipart. If a door latch is within this range, do not install and order a new one.
